Database development on SCC from a retired steam generator

Seong Sik Hwang*, Jangyul Park, Hong Pyo Kim

Korea Atomic Energy Research Institute, 1045 Daeduckdae-ro, Yuseong-Gu, Daejeon 305-353,

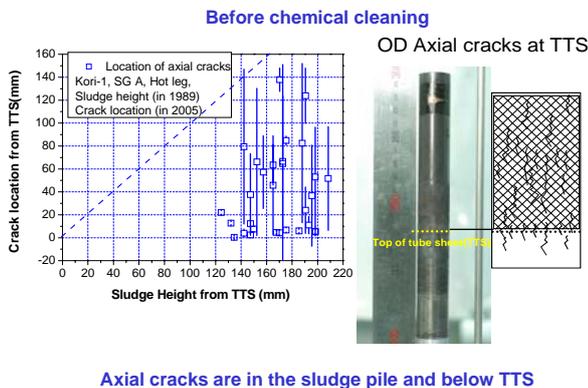
Fig. 1 Axial Crack location at TTS region

TSP. Some cracks were observed at a free span region. Axial cracks of TTS were believed to be located within the sludge pile before a chemical cleaning as shown in Fig. 1.

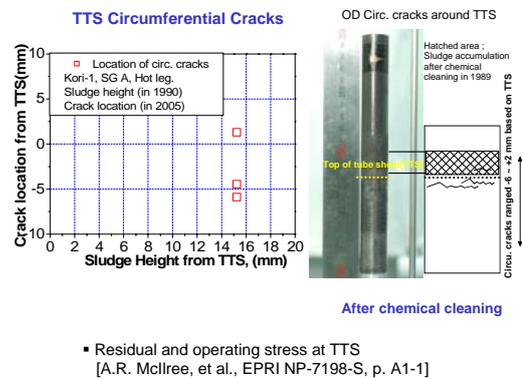
On the other hand, circumferential cracks were found below the TTS as shown in Fig. 2. According to A. McIlree[1], circumferential cracks are caused by residual stress and operating pressure difference at the TTS region. The confined location of the circumferential cracks below TTS means that a residual stress by sludge pile is high enough to invoke the cracking.

Fig. 2 Location of the circumferential cracks at TTS region

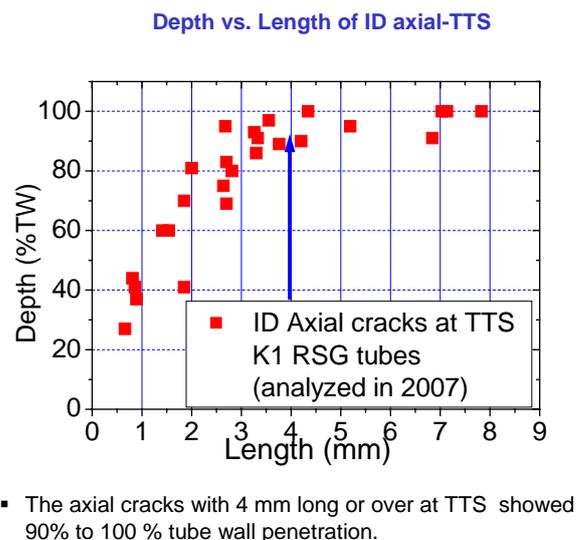
A depth of the ID axial cracks was 90 % of the tube wall when the lengths of the cracks are over 4 mm as shown in Fig. 3-(a).

Fig. 3-(a) Relationship between depth and length of ID axial cracks at TTS.

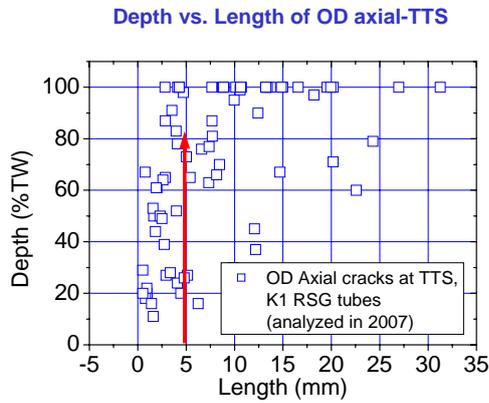
Fig. 3-(b) represents the depth of the OD axial cracks with increasing crack length. These OD axial cracks show shallower wall thickness penetration than ID axial cracks even the crack length is 15 mm. This means a corrosive environment was severer in OD side of the tube by sludge accumulation than in tube ID surface condition of a cracking.

- The OD axial cracks with 5 mm long or over at TTS showed 90% to 100 % tube wall penetration.

Fig. 3-(b) Relationship between depth and length of the OD axial cracks at TTS

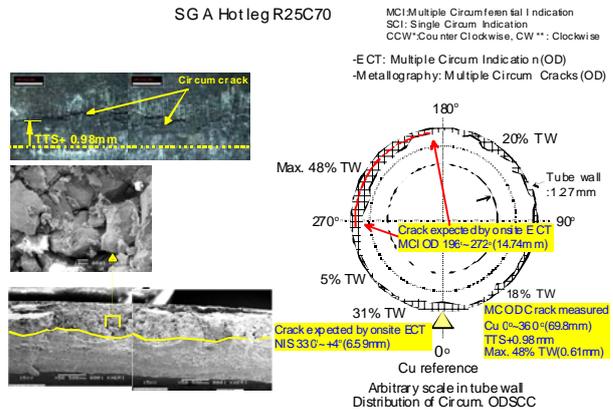
Fig. 6 shows an example of detail information of a tube which has circumferential cracks. There were deeper cracks in ECT indicated area (196°~ 272°) in a multiple circumferential mode, some shallow cracks were also detected all around the tube circumference. The depth

of the cracks, however, was 48% in maximum of the tube wall. So those shallow cracks might not be detected by a normal ECT.

Fig. 6 Detail crack information of a tube having circumferential cracks.
