Characteristics of SCC Defects of Retired Steam Generator

Seong Sik Hwang, Man Kyo Jung, Hong Pyo Kim, Joung soo Kim
Korea Atomic Energy Research Institute, 150 Deokjin-dong Yuseong-Gu, Daejeon 305-353, Korea
sshwang@kaeri.re.kr

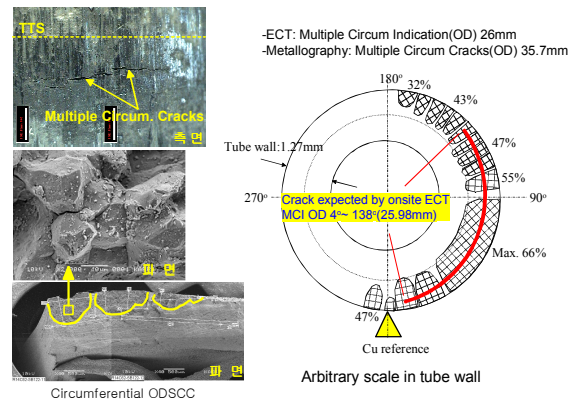
Fig. 2 A representative of a destructive analysis

Fig. 2 is a representative of defect analysis result. Circumferential cracks, of which maximum penetration depth is 60%, were distributed along the half of the circumference.

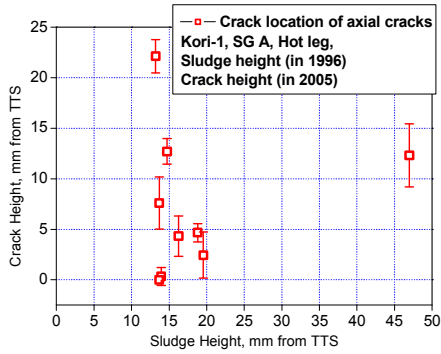
A relationship between axial cracks height and sludge height is depicted in Fig. 3. Most axial cracks were located at a sludge region. On the other hand, circumferential cracks are in the sludge pile and below TTS as shown in Fig. 4.

Fig. 3 Relationship between height of axial cracks and sludge height

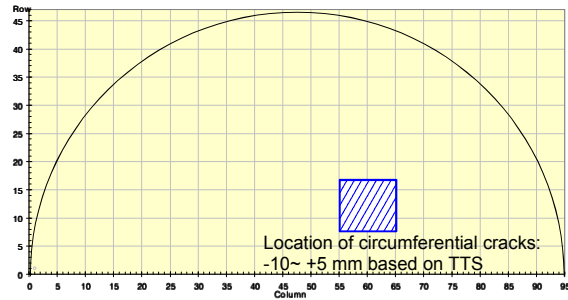
Fig. 6 Distribution of Location of circumferential cracks.

A SCC location in terms of row and column number was presented in Fig. 5 and Fig. 6. There is a specific region of observed area of axial cracks and circumferential cracks. The location seems to be related to the sludge location and tube expansion region(TTS).

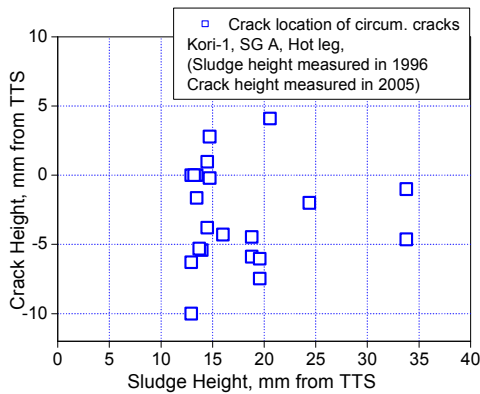
Fig. 4 Relationship between height of circumferential cracks and sludge height

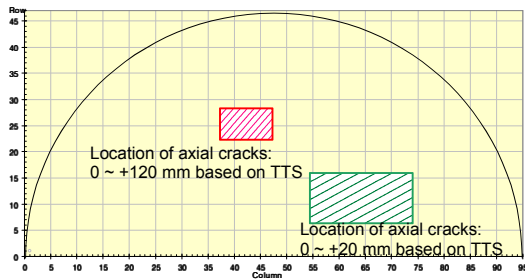
Fig. 5 Distribution of Location of axial cracks.
