The Status of the Damaged Fuel Assemblies in HANARO

Mun Lee, C.S. Lee, K.H. Lim, G.H. Ahn

HANARO Management Division, KAERI, 150 Deokjin-dong, Yuseong-gu, Daejeon, KOREA

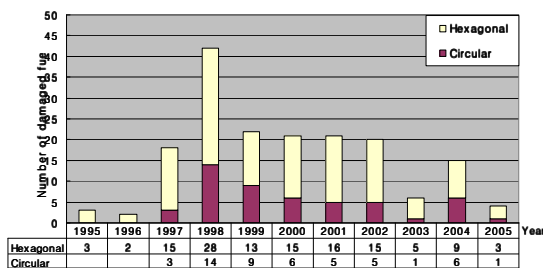
Figure 2.1 Status of the Damaged Fuel for each year

Figure 2.1 shows the damaged fuel for each year. The number of damaged fuels at the beginning of the reactor operation in 1995 and 1996 was only 5 hexagonal fuels. Those arose from reactor operators' carelessness and mismanagement. In 1997, it was confirmed that 3 of the circular fuels and 15 of the hexagonal fuels were damaged severely through the visual inspection.

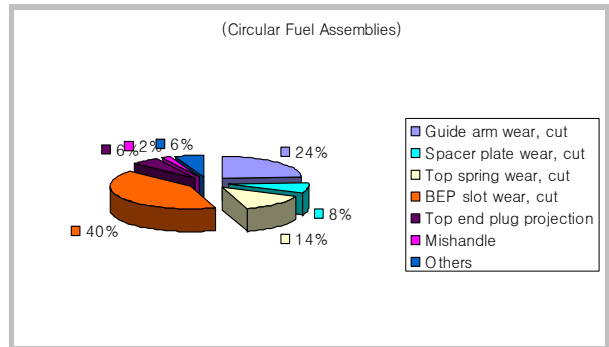
Figure 2.2 Distribution Chart of the Damaged Fuel Assembly

As it can be seen in Figures 2.2 and 2.3, the major damage of the hexagonal fuel assemblies was a corner pad of the spacer wore out ear and cut 77 % which were occurred by a fretting after the primary pump runs about 100 days. In the case of the circular fuel assemblies, 40 % of the damaged fuels appeared that slot for the bottom guide at BEP (Bottom End Plate) was enlarged. Most of these damages were caused by the FIV (Flow Induced Vibration) in the fuel channels [1-3].
