## In-Bay Visual Examinations of Post-Irradiated CANDU Fuel Bundle

Ji Su Jun, Chang Keun Jo, Jong Yeob Jung, Dae Seo Koo and Moon Sung Cho  
Korea Atomic Energy Research Institute, P.O.Box105, Yuseong, Daejeon, Korea 305-600  
[junjsu@kaeri.re.kr](mailto:junjsu@kaeri.re.kr)

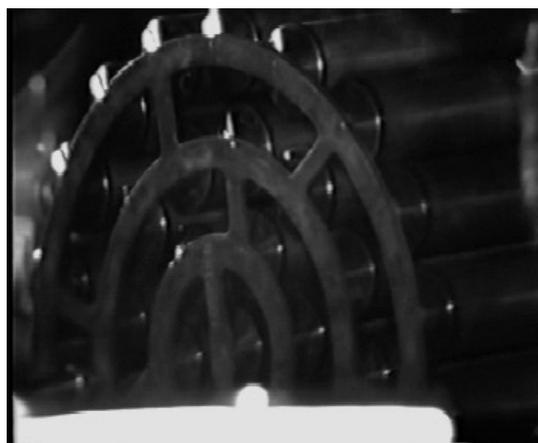
Figure 2 examines the front view of endplate to find out any cracks which may be caused by a impact or a long period residence in the cross

flow during refueling. This view can read the serial number of bundle and K mark on the endplate. There is no evidence of cracks or local deformation on the endplates of eight PI bundles.

Fig.2 Examination of Surface on Endplate

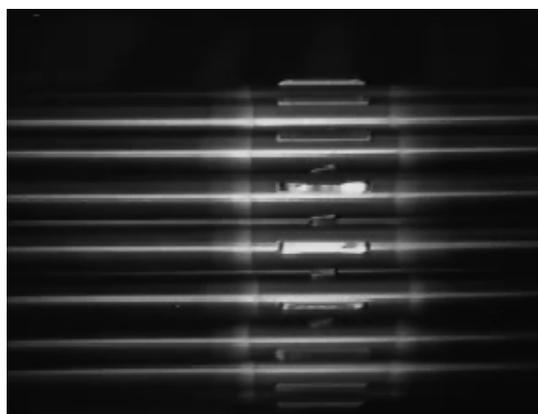
Figure 3 focuses on the surface of elements (including bearing pads) at the mid-spacer plane of bundle. All the surfaces of 18 outer rods can be examined by slowly rotating bundle. Some minor wears or scratches appear on the surfaces of bearing pads and elements for bundles in high power channel (O-07). But, most of rod surfaces look clean. Excessive spacer fretting will appear as “notches” between spacers. It is difficult to find out any signs of excessive spacer fretting by focusing the camera at the mid-spacer plane of bundle. Rods may be bowed radially outwards/inwards or be S-shaped by experiencing the non-uniform conditions of coolant temperature, heat generation and axial loading in a rod. During the visual inspection, most of elements look fine but the definitely bowed rods appear on bundles in high power channel (O-07 and Q-15). A slight bowing (less than 0.50 mm) appears on even the fresh bundles [5]. So, it is difficult to determine in-bay visually how much bowing happens on the PI bundle. Based on the results of the dimensional measurements [2], the maximum bowing and the bowed rods are summarized in Table 2. Some significant bowing (1.2mm~2.5mm) appear on the several elements of O-07 channel bundles. But, the S-shaped bowing does not happen.

Fig.3 View of Mid-Spacer Plane of Bundle
