Surface Analysis on Pulled Steam Generator Tubes from Kori 1 Nuclear Power Plant

H. P. Kim, S. H. Eom, M. K. Jeong, D. J. Kim, Y. S. Yi, S. S. Hwang, Y. S. Lim, J. S. Kim
Division of Nuclear Material Technology Developments, Korea Atomic Energy Research Institute(KAERI), Yuseong,
Daejeon, Korea, 305-600

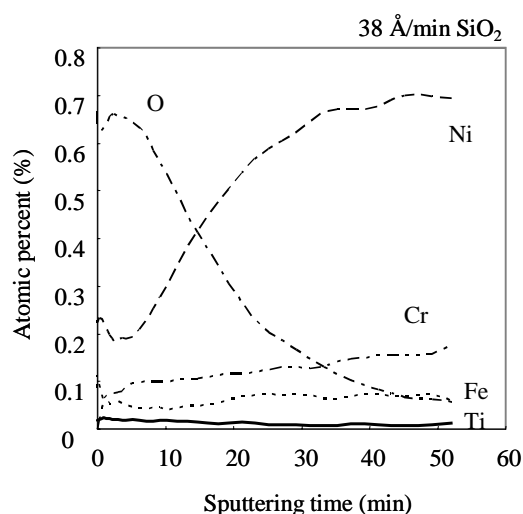
Figure 1 shows the depth profile of the surface oxide by the AES. In the AES analysis, Ti more than 2% was detected. Since this amount of Ti is much more than the nominal content of Ti in Alloy 600 it can be speculated that TiO_2 is soluble in the simulated secondary side water and the Ti ions in the solution is deposited to the surface of Alloy 600 tubes.

The analysis results by the EDS and AES are not consistent each other (Table 2 and Figure 1). This is due to the relatively thin surface oxide of the alloy and the large electron beam size in the EDS analysis. Thus, the analysis result by the EDS was judged to include the compositions of the base alloy as well as those of the surface oxide, which underestimated the actual content of Ti in the surface oxide.

Fig. 1 AES depth profiles of main elements in the surface oxide on Alloy 600 formed in an ammonia solution ($pH_{RT} = 9.8$) at 315°C for 5days.
