### Measurement of Cladding Ovality at the Defect Area of Irradiated PWR Fuel Rod

J09-L01

### Abstract

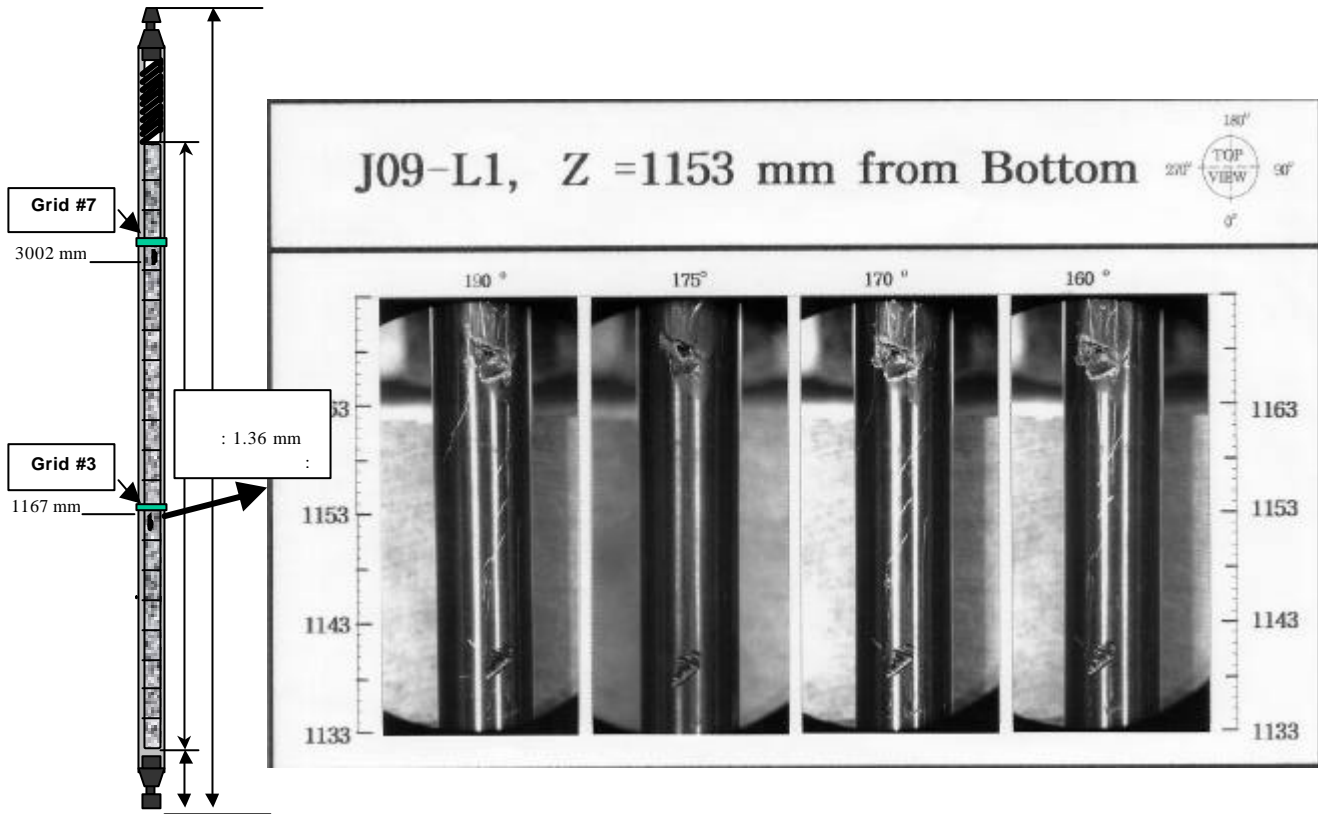
1. J09-L01

1,167mm

3

1.36mm,

3.18mm

1,138mm

( 1).

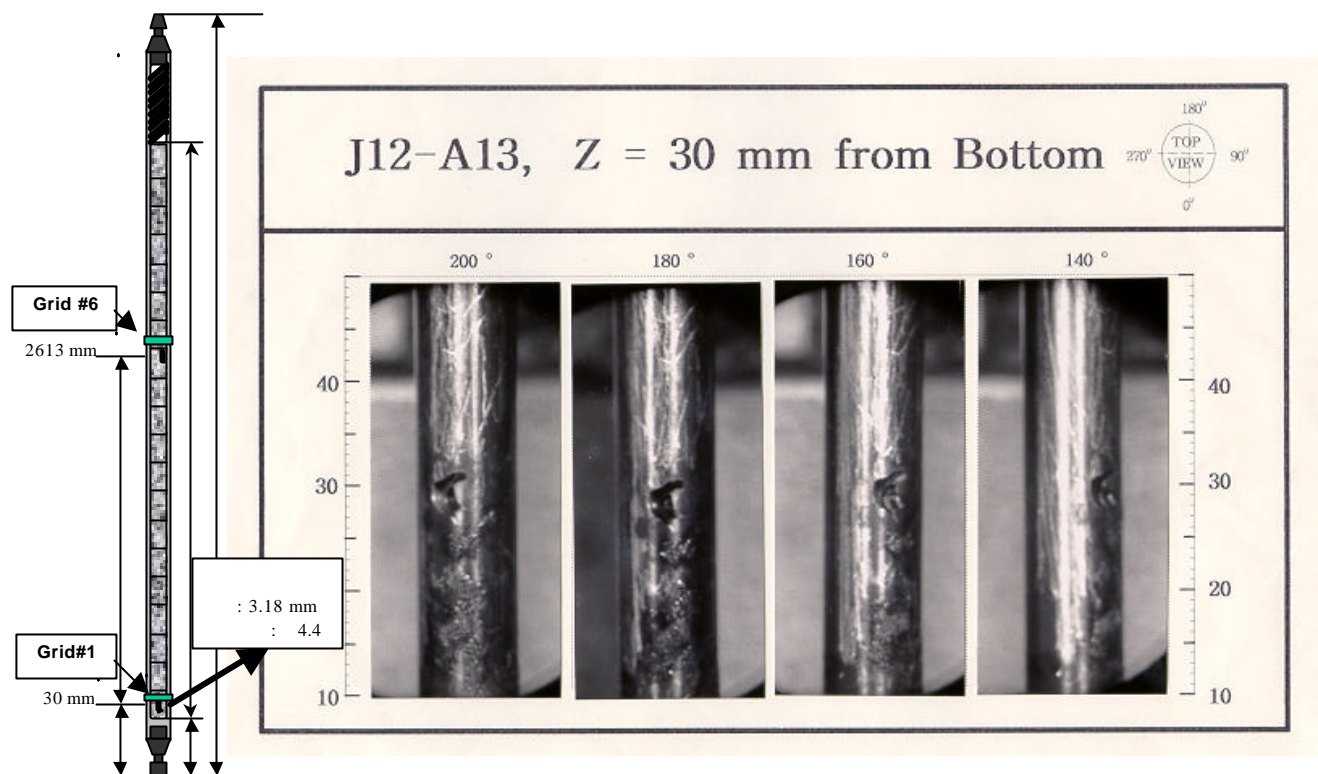
2. J12-A13

J12-A13

30mm, 1

4.4mm

3.18mm

1.36mm

0.9mm

( 2). J09-L01

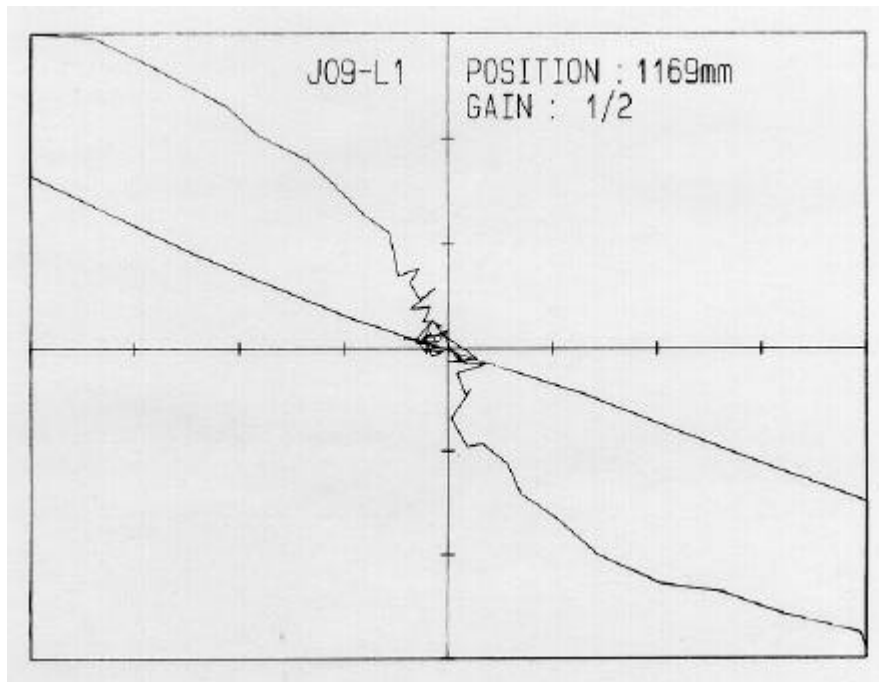
3. J09-L01

3

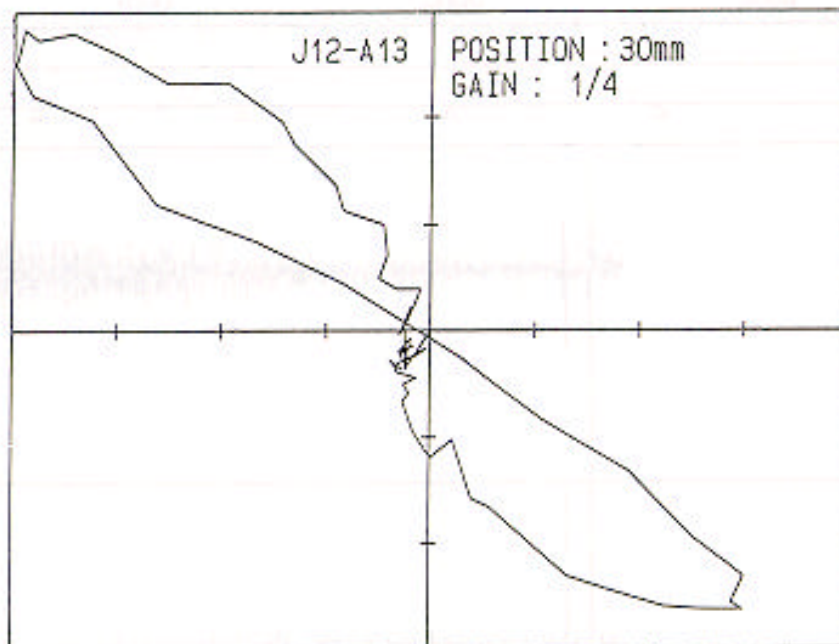
4. J12-A13

4

30mm

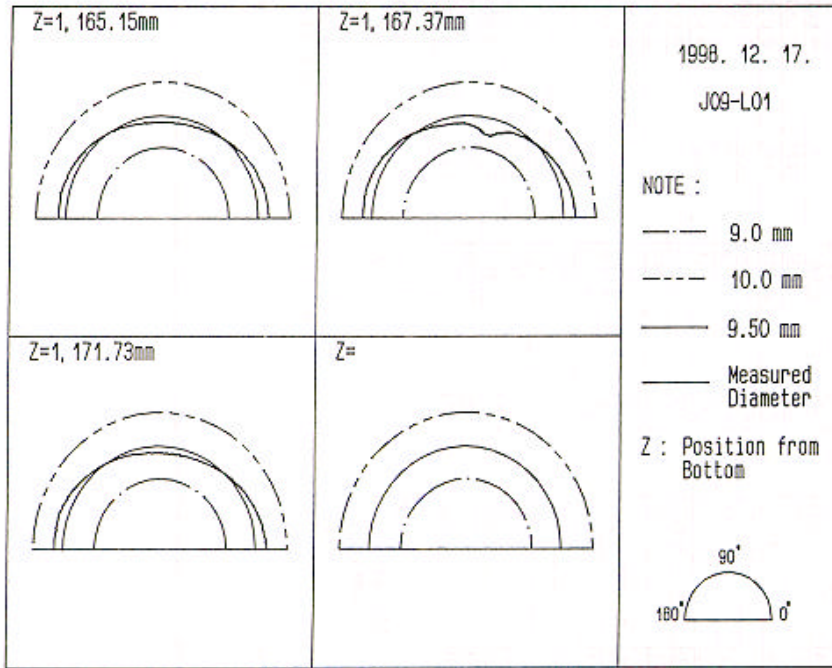
5. J09-L01

5

1,137mm

1,167mm

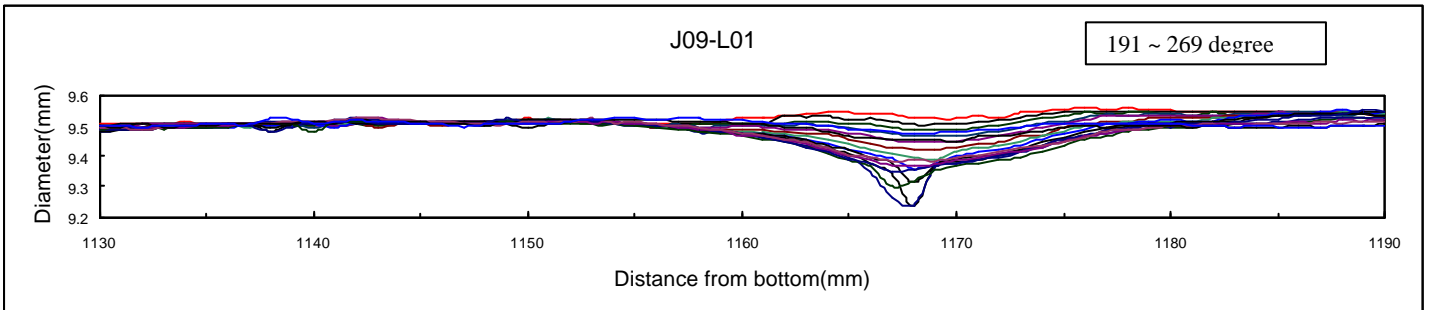
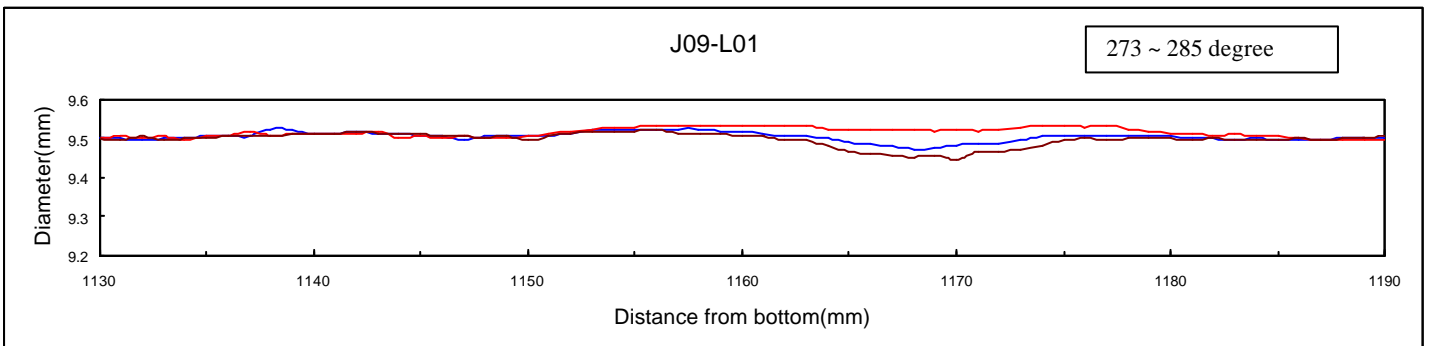
6. J09-L01

1,167mm

6

0.15mm

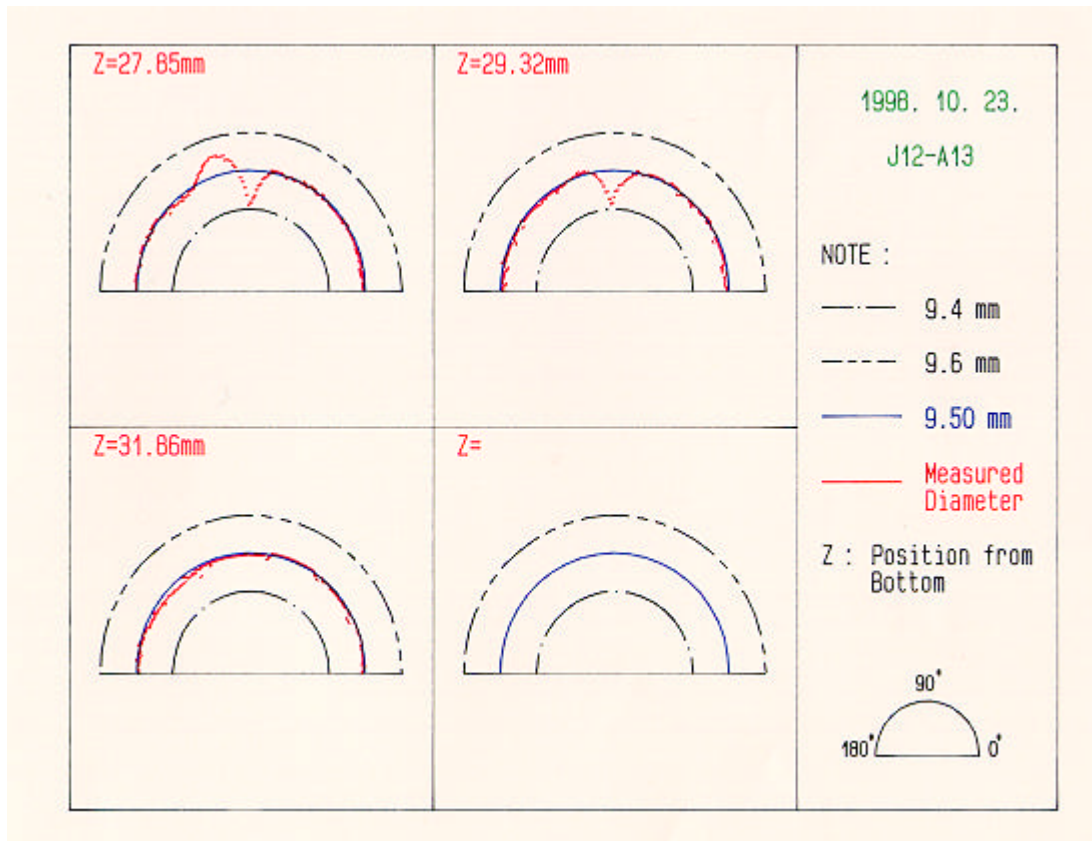
7. J12-A13

7 J12-A13

30mm

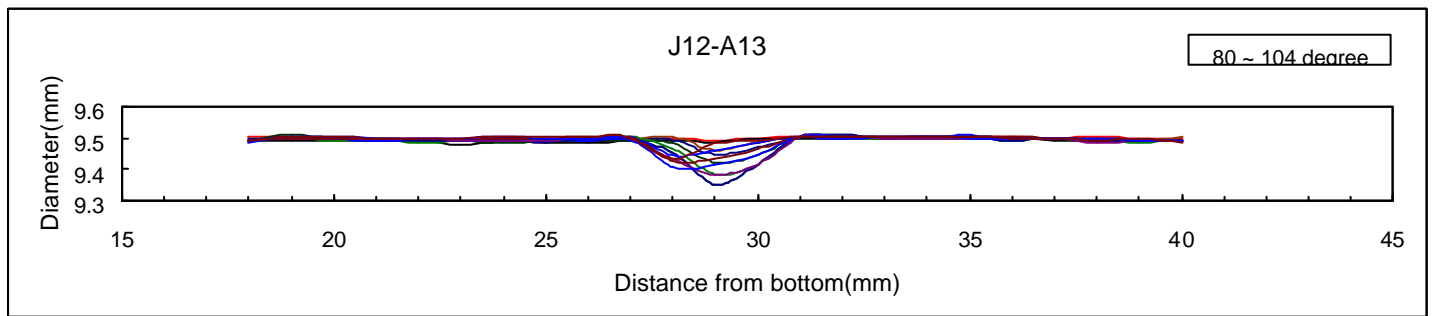
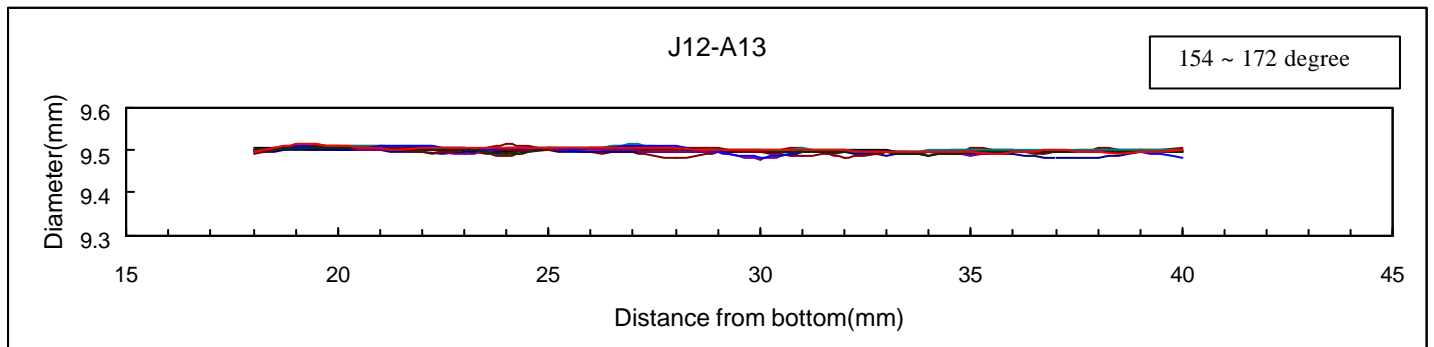
8. J12-A13

8

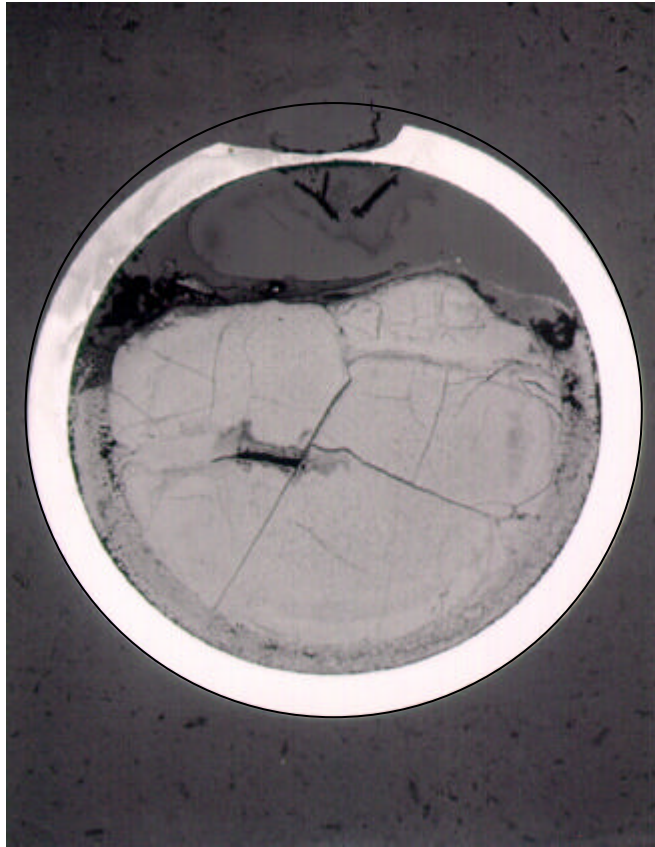
9. J09-L01

9

J09-L01
