Introduction of Containment Liner Plate (CLP) Corrosion

Yonglak Paek¹, Sangyun Kim¹, Euisik Yoon¹, Hun Cha²

¹Principal Researcher, Korea Institute of Nuclear Safety (KINS), South Korea

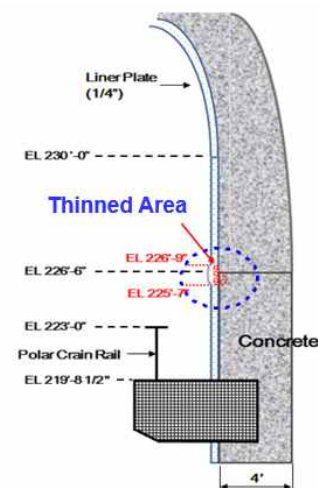
Fig. 1. Characteristic of CLP

Most of corrosion were found mainly along the CJ between cylindrical wall and dome shown in Fig. 1.

During construction of containment wall, this location had been exposed to outside environment relatively for a long time. The outside environment like chloride flown by air from the ocean can provide the condition easy to corrode steel plates. It was analyzed that this chloride and water content from the ocean nearby Nuclear power plant (NPP) would come into the gap between liner plate and concrete at the CJ during long exposure period to environment. For passive oxide film on the liner plate damaged by the lowered pH, crevice corrosion was initiated.
