Vertical sea water pump Al-bronze impeller predictive maintenance technique by using vibration frequency analysis

Dong Kyu Yeo ^{a*}, Chi Bum Bahn ^a

^a School of Mechanical Engineering, Pusan National University, Busan, Republic of Korea

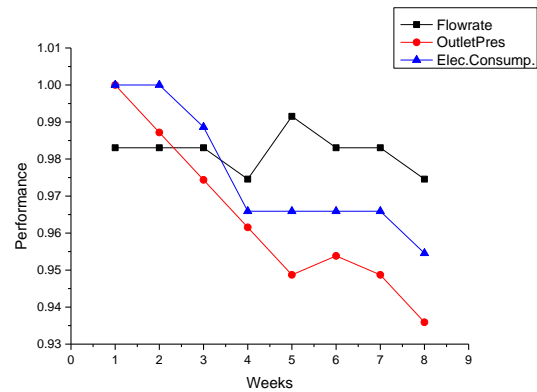
For approximately 8 weeks, the pump performance (flow rate, outlet pressure) decreased significantly, and the power consumption also decreased. During the instantaneous inspection of the main control room, the performance degradation was recognized and predictive maintenance was performed. The performance trend is identified as shown below. [Fig. 1.]

Fig. 1. Case A. Performance parameters(Flow rate, outlet pressure) and electric consumption significantly decreased during only 8 weeks.

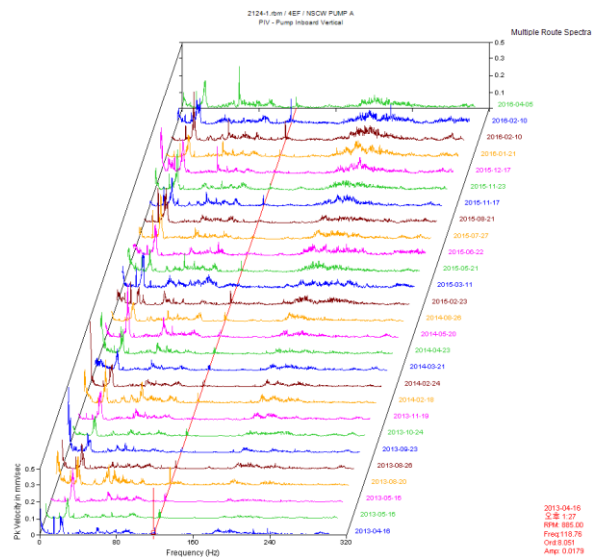
Element	Description
0~1X	Increased from early to mid cycle, calms down at end of cycle
1X	Increased from early to mid cycle, calms down at end of cycle
4X	Increase due to wear at the end of cycle
8X	Intermittently occurred, and it occur again at the end of cycle and maintained

In total, cavitation erosion accompanied by foreign matter occurred at the point where 0 ~ 1X component and 8X peak occurred, and at the end of the cycle, bearing erosion also affected the 4X component. [Fig. 2.]

Fig. 2. Vibration frequency waterfall diagram of Case A. (PIV)

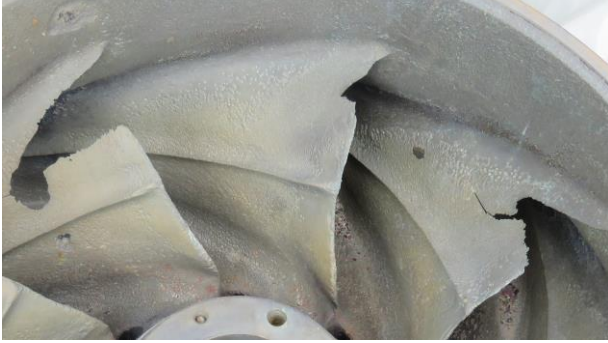
In Cases A, pump overhaul results in severe erosion damage from cavitation and debris on the impeller and vane surfaces. More than 5% of the total area of the material was completely lost or thinned like paper due to cavitation and foreign material. [Fig. 3.]

Fig. 3. Serious comprehensive damage of erosion such as pitting on the surface and sharp cross section of the impeller vane.

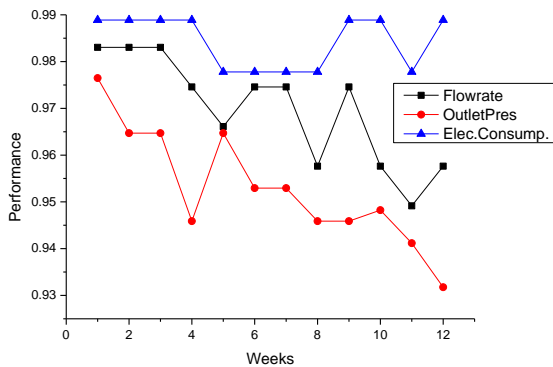
During approximately 12 weeks, the pump performance(flow rate, outlet pressure) was similarly reduced with power consumption, and the power consumption also fluctuated. The 3-month cycle performance test was barely satisfactory, but predictive maintenance was performed due to the sharply reduced performance margin. The performance trend is identified as shown below. [Fig. 3.]

Fig. 4. Case B. Performance parameters(Flow rate, outlet pressure) decreased significantly to approximately 95% and electric consumption fluctuation during only 12 weeks.

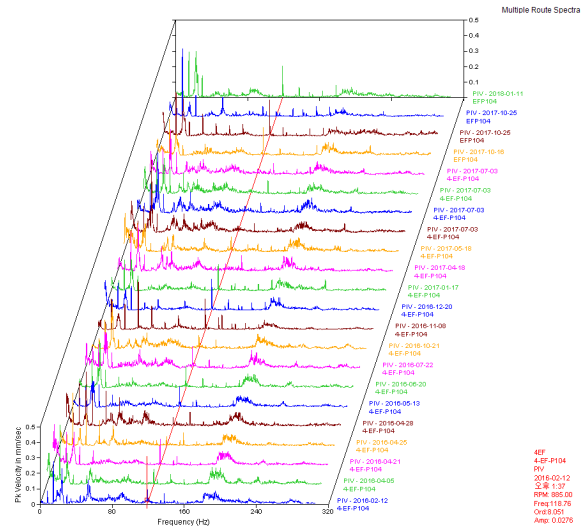
Since 2X, 4X and its harmonics are observed from the beginning of the cycle, it is estimated that there was a defect in assembly during the final maintenance. 8X is also a harmonic wave of 2X and 4X, and 0 ~ 1X components are intermittent, but they are rarely observed, so it is difficult to grasp the effects of erosion and cavitation by foreign substances. In conclusion, as a

result of the pump failure maintenance, the rope was wound around the impeller. [Fig. 5]

Fig. 5. Vibration frequency waterfall diagram of Case B. (PIV)

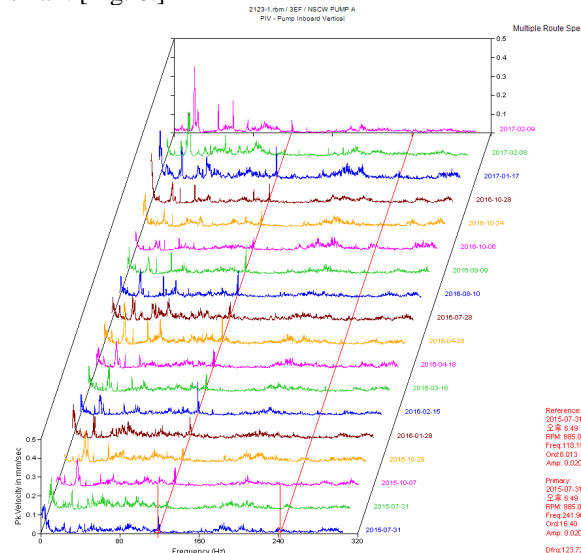
Although Peak is smaller than Case B, 2X, 4X, and its harmonic wave have appeared steadily from the beginning of the cycle, but the 0 ~ 1X component is not so prominent, so it can be judged that the influence of erosion and cavitation by foreign matter is relatively small. [Fig. 6.]

Fig. 6. Vibration frequency waterfall diagram of Case C. (PIV)

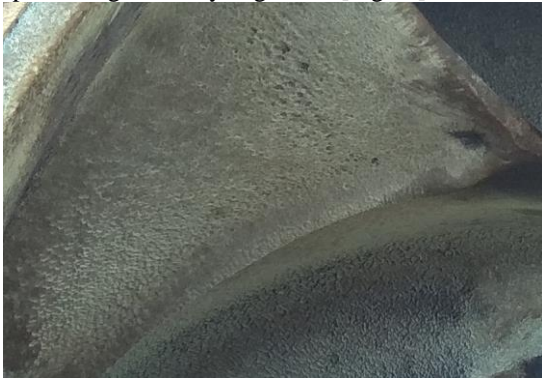
As a result of pump disassembly, pitting was widely observed on the surface of impeller and vane. 5 to 10 complete penetration erosion sites of small size (less than 5 mm in diameter) were identified. Appearance is maintained throughout, but material losses have already

occurred and surface hardness and mechanical properties significantly degraded. [Fig. 7.]

Fig. 7. Al-bronze impeller surface with cavitation pitting after 3.5 years operating without performance degradation and significant vane pass frequency peak.

Including the above cases, we analyzed several cases where sudden performance degradation did not occur during the predictive maintenance cycle. The overall low and irregular 0~1X element and VPF(8X) oscillation peaks indicate that the impeller erosion was not severe and there was no unbalanced damage. Although there is some difference between the operation period and the degree of erosion, a wide range of pitting has been observed such as [Fig. 7.], suggesting that the current maintenance cycle (approximately three years) is appropriate.
