Lessons at the Fukushima Daiichi Accident

Sang Jin Son^{a*}, Moosung Jae^a

Nuclear Safety Analysis Laboratory in Hanyang Univ, PA+82-2-2220-1346

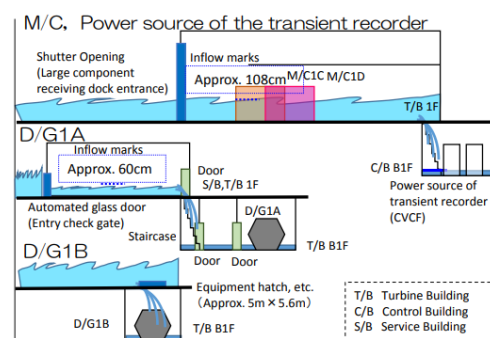
The massive tsunami, which reached its highest level of 15 meters after the quake, hit the Fukushima Daiichi nuclear power plant. The tsunami and the resulting floaters damaged the reactor, making normal heat removal difficult, and because the emergency diesel generator was installed underground, it was submerged by the tsunami and became unusable, leading to SBO (Station Black Out) situation where the pumps supplying cooling water for the reactor could not supply.

Fig. 1. Tsunami inflow into turbine building [TEPCO]

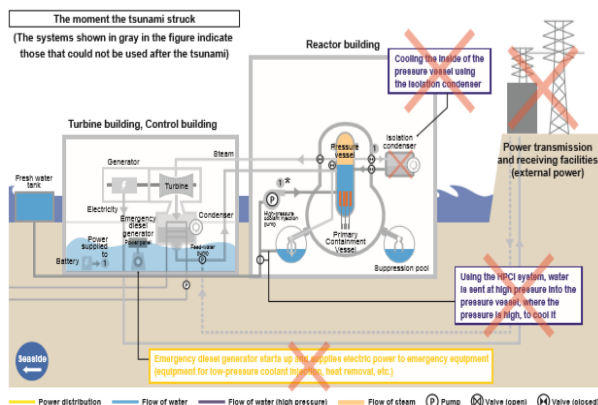
The high temperature and high pressure inside the containment vessel persisted for a long time the pellet and cladding melted as all the coolant evaporated, and finally the reactor pressure vessel melted. With the explosion of hydrogen gas at unit 1, the radiation dose rate near MP-4 was measured by mobile vehicles and it was shown that it soared to approximately $1100\mu\text{sv}$ per hour.

Fig. 2. The unit 1 after tsunami [TEPCO]

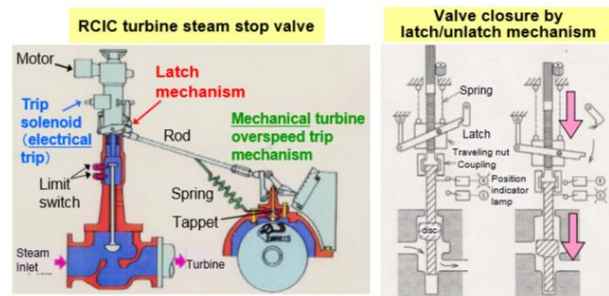
Fig. 3. Schematics of RCIC turbine steam stop valve and its trip mechanism [3]

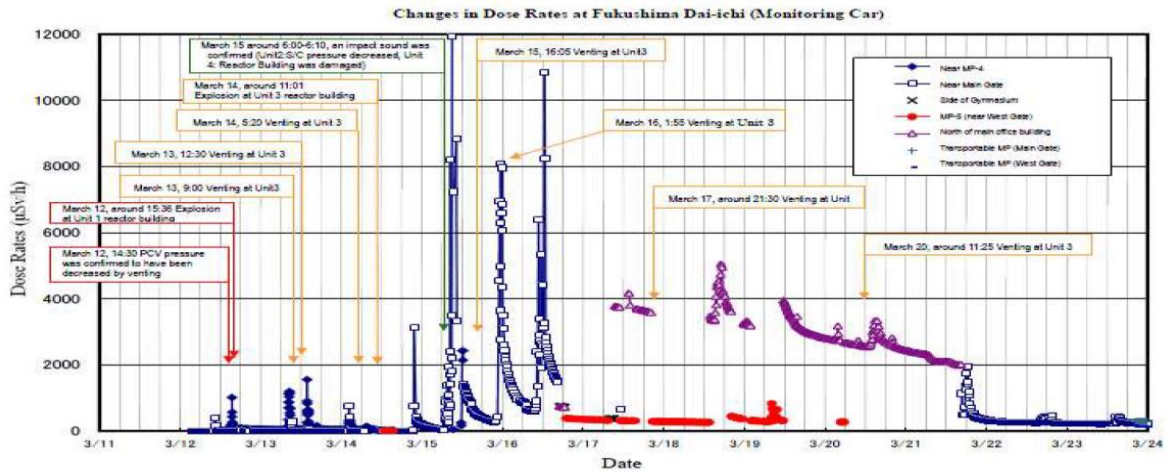
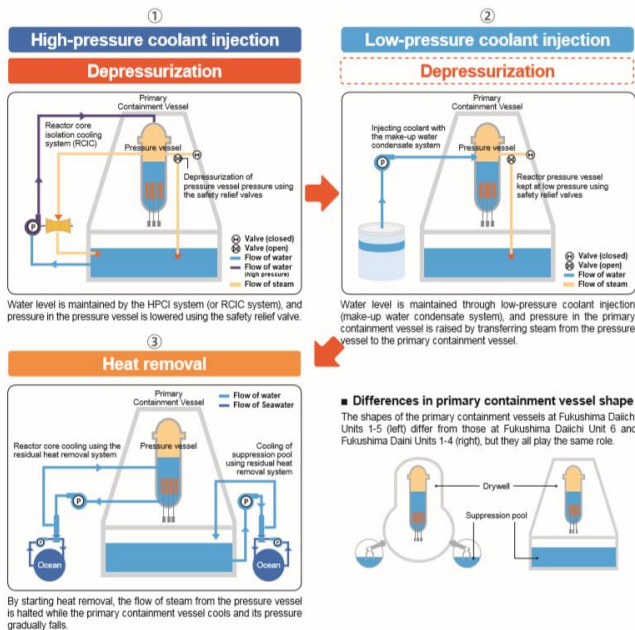
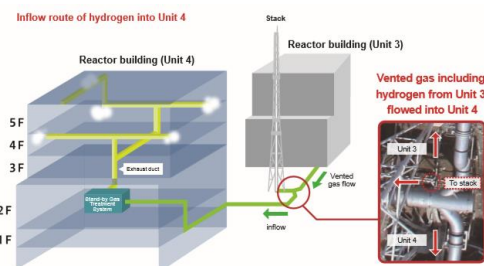
The unit 4 reactor had been suspended since November 2010, due to a decomposition check, and all nuclear fuel had been removed from the reactor and kept in the spent fuel pool. However, hydrogen gas explosion occurred at the reactor building of unit 4 around 6 am on March 15 [6]. The spent fuel pool was safe, but hydrogen gas explosion occurred due to backflow of exhaust from the third vent. As shown in Figure 6, units 3 and 4 appear to have been moved to the system of units 4 in reverse during the venting process of units 3 because they are used for public exhaust chimney. The results showed that the radiation dose rate with the moving vehicle soared to 12000 μ Sv per hour when measured near the main gate.

Fig. 6. Hydrogen gas transfer path through public exhaust chimney of units 3 and 4 [TEPCO]
