## Effect of the Molten NaCl-MgCl<sub>2</sub> Salt on the Corrosion of 316 Stainless Steel

Hwa Jeong Han<sup>a</sup>, Hyunjin Boo<sup>a</sup>, Jonghyeon Kim<sup>a</sup>, Su Hyeon Lee<sup>a</sup>, Su Hyeon Kim<sup>a</sup>, Byung Gi Park<sup>a\*</sup>

<sup>a</sup>Department of Energy and Environmental Engineering, Soonchunhyang University, 22 Soonchunhyang-ro, Asan-si, Chungcheongnam-do, 31538, Republic of Korea

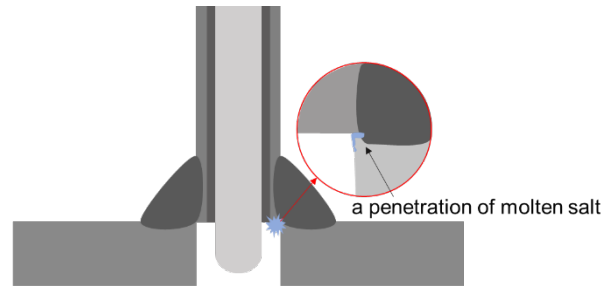
totally to the inside, the corrosion is thought caused by the penetration of molten NaCl-MgCl<sub>2</sub> salt into the gap(or crack). Fig.2. explains the penetration of the molten NaCl-MgCl<sub>2</sub> salt to the crack by the weld defects.

Fig. 2. the penetration of the molten NaCl-MgCl<sub>2</sub> salt to the crack(or gap) by the weld defects.

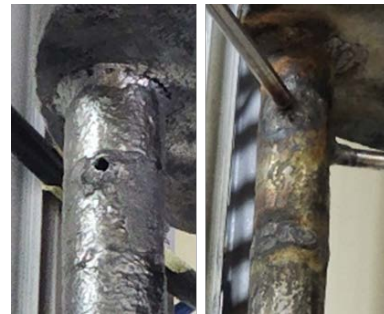
Fig. 3. the broken part by corrosion(left), the repair weld of a broken part, and the heat affected zone(right).

The problem occurred again in the repair welded part. The repair welded part was broken after several hours had elapsed in high-temperature operation. The shape of the broken part was the re-welded part connecting the pipe and the tube to the previous welded part.

It is estimated that hot cracking, which is known as a problem in welding austenitic stainless steel, and weld decay caused by sensitization are the causes of the problem. It mainly occurs in HAZ, which appears inevitably during welding, and a Cr-depleted zone near the grain boundary is created in the base material that is subjected to a temperature range of about 500 to 750 °C.

After that, 1/4 inch was repaired using a 308 stainless steel welding rod. Unlike the previous welding method, the repair welding was welded by inserting a part of 1/4 inch pipe into the 1-inch pipe and welding the boundary all around. At this time, the effect of the heat affected zone (HAZ) was observed on the surface of the repaired welded area like as Fig.3.

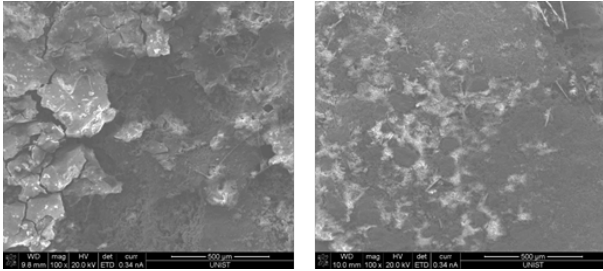
Fig. 4. the surface SEM images of the broken part. (left: top edge, right: bottom edge)

Additionally, the EDS analysis was performed on the broken part. The surface EDS result of the broken part of the weld and pipe was analyzed to be an average Cr ratio is about 5wt% or less, which is unreasonably low compared to the generally known Cr composition ratio. As a result, it can be seen that Cr ions are depleted and Mg ions are deposited at the depleted sites.

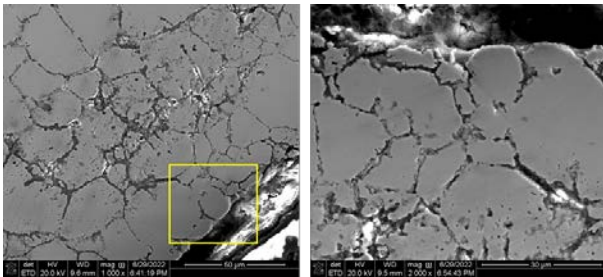
Fig. 5. the cross-section SEM images of the broken part.

A clear intergranular corrosion pattern was observed in the cross-sectional SEM image of where the corrosion occurred in the weld. Its length is about 100 µm or more, and in fact, the welded part was continuously exposed to a high-temperature condition during welding and operation.

As a result, chromium at the grain boundary combines with carbon and precipitates at the grain boundary, resulting in a chromium depleted layer, which deteriorated the corrosion resistance of this part and causes corrosion. As is known, this sensitization occurs in the temperature range of 550 to 800°C, and since the operating temperature in this experiment was 600°C on average, it can be seen that it was the cause of intergranular corrosion.

The SEM results of the broken welded part due to corrosion can be confirmed that serious intergranular corrosion occurred compared to the operating time. That means that the effect of the molten NaCl-MgCl<sub>2</sub> salt on the corrosion of welded part must be considered.
