## Analysis on cracking of baffle former bolts from a PWR plant

Seong Sik Hwang<sup>a,\*</sup>, Sung Woo Kim<sup>a</sup>, Min Jae Choi<sup>a</sup>, Hong Pyo Kim<sup>a</sup>, Dong Jin Kim<sup>a</sup>,  
Ki Soo Heo<sup>a</sup>, Young Gwan Jin<sup>a</sup>

<sup>a</sup> Korea Atomic Energy Research Institute, 989-111 Daedeok-daero, Yuseong-gu, Daejeon 34057, Korea

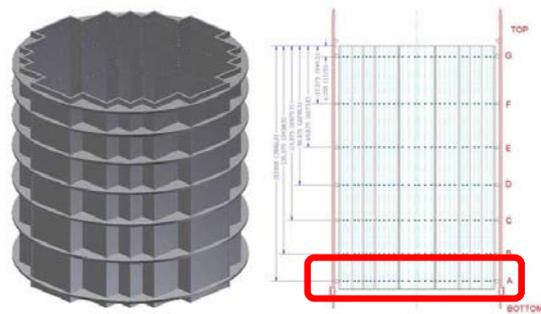
The nuclear power plant has a structure in which 728 baffle former bolts and 176 baffle plate edge bolts made of type 304 stainless steel are connected to each other to support the nuclear fuel assembly as shown in Fig.1. The bolt material connecting these two plates is cold worked type 316 stainless steel. During the in-service inspection in May 2015, a defect named UDL (Unknown Defect Location) was found on eight bolts in symmetrical locations in four places of the lowest former. Fig. 2 is the defect signal obtained from the field inspection. A clear backwall signal was found in sound bolts, whereas no such signal was found in defective bolts. Based on this, the form of the defect was unknown, but it was determined that there was some discontinuous defect.

Fig. 1. Location of defect signal bolts (lowest former)

- A defect named UDL (Unknown Defect Location) was found on 8 bolts in symmetrical locations in 4 places of the lowest former in a Korean plant.

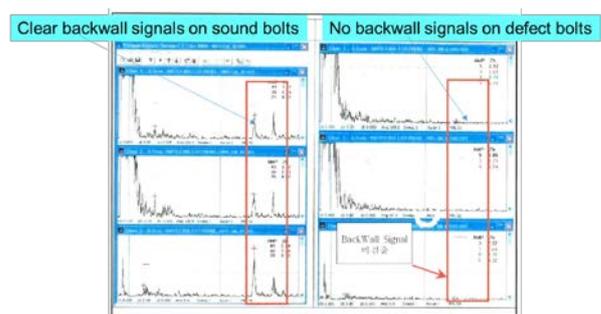
Fig. 2. Comparison of NDE signals on sound and defect bolts

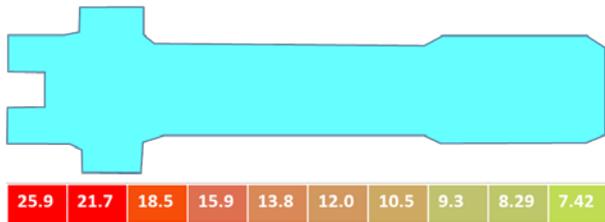
Fig. 3 shows the high-speed ( $E > 1.0$  MeV) neutron cumulative dose calculated from the head of the bolt to the lower screw for one of the defective bolts of the plant. Because it is the lowest former location, the amount of irradiation was calculated to be less than that of the belt line location, but it shows a value of about 26

dpa(displacement per atom) which is larger than the critical value (about 2.5 dpa) that causes IASCC.

Fig. 3. Fluence (DPA) calculation on a defect bolt

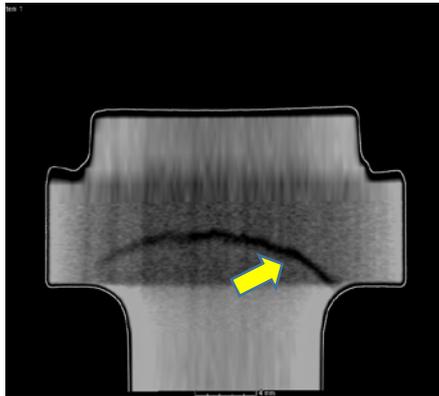
Before viewing the fracture surface with a scanning electron microscope, 3D computed tomography X-ray photos were taken to determine the shape of the defect. As shown in Fig. 4, clear defects are shown in the shank area just below the head.

Fig. 4 X- ray 3 D CT image on a defect bolt

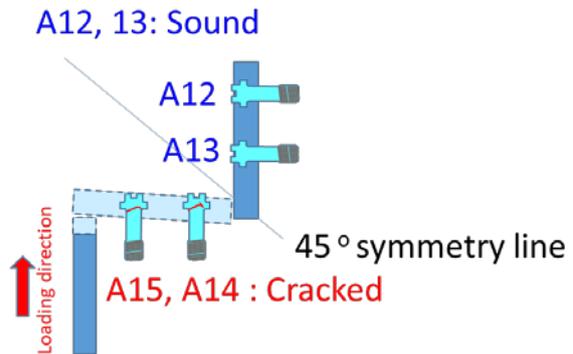
The fact that crack defects were found at exactly symmetrical 4 locations was determined that the main cause of the defect was stress caused by the structural factor in which the bolt was fastened, rather than the factor of the material or operating environment. Fig. 5 shows a schematic of asymmetrical applied load on the bolts. It is assumed that tensile stress was applied to the defective bolt due to radiation induced void swelling or asymmetric stress from other factors. This would explain the defect found only on the A14 and 15 bolts, but not on the A12 and A13 bolts, which are perfectly symmetrical in terms of nuclear fuel arrangement and distance. A more precise stress analysis may be performed and the results will be published later on.

Fig. 5. Different stress conditions due to asymmetrical applied load on the defective bolts
