Analysis of Unplanned Shutdown in HANARO: Thermal Analysis of Thermal Overload Relay for Shutoff Rod Pump Motor

Hun Young Kim*, DongHyuk Lee

Korea Atomic Energy Research Institute, 111, Daedeok-daero 989 Beon-gil, Yuseong-gu, Daejeon 34057, Korea

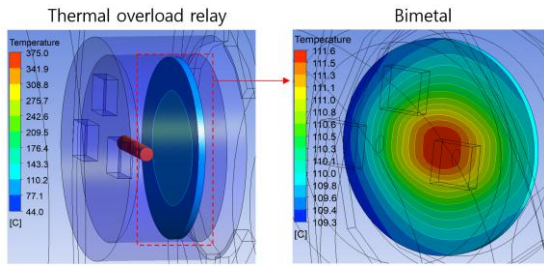
Figure 2 shows the numerical results of the TOR for SOR pump motor #2 under incident conditions. Since the triggering temperature range of the bimetal within the TOR is estimated from 105°C to 110°C, it can be confirmed that SOR #2 dropped due to the triggering of the TOR caused by motor overheating. Table 1 presents the operating currents and the corresponding bimetal temperature ranges for the other SOR pump motors under the same conditions. The results indicate that while the bimetal temperature of SOR pump motor #2 was the highest, the bimetal temperatures of the remaining pump motors were also within the trigger range, suggesting a high potential for recurrence.

Fig. 2. Numerical results of the TOR for SOR pump motor #2 under incident conditions.

Several actions were carried out to improve the operating environment. The acrylic cover was removed to increase the cooling efficiency of the pump motors, and the pit's temperature would be monitored. Additionally, SOR pumps #1 and #2 were replaced. The operating currents of the replaced pumps were 8.5A to 8.6A. Since SOR pump motor #3 now has the highest operating current, the bimetal temperature variations for this motor were calculated while changing the pit temperature. The results confirmed that maintaining the pit temperature below 35°C is necessary for the stable operation of the SOR pumps. Although removing the acrylic cover should significantly reduce the pit temperature because the reactor hall is maintained at approximately 25°C, the installation of cooling fans may be required if the pit temperature rises due to poor air circulation.
