Analysis on SCC of Retired Steam Generator Tubes by Using a Multi-Parameter Algorithm and Destructive Method

Ch. Nam-Gung*, Y.M. Cheong, H.P. Kim, S.S. Hwang

Korea Atomic Energy Research Institute, 150 Deokjin-dong Yuseong-Gu Daejeon 305-353, Korea E-mail*: chan@kaeri.re.kr

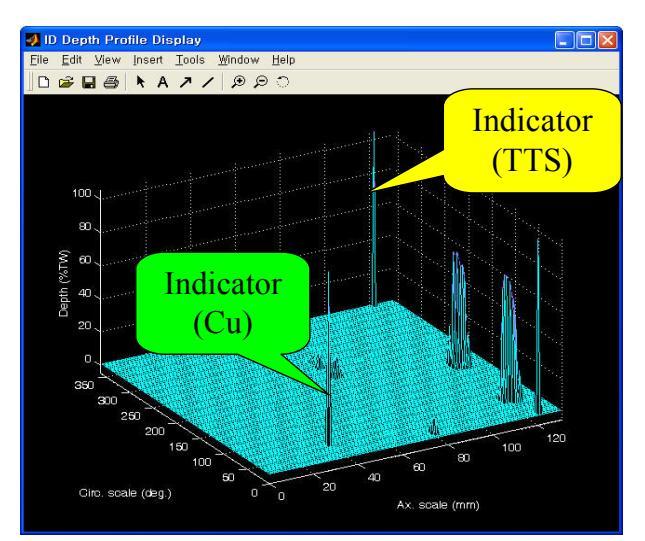
The data were acquired through channels with various frequencies. Only one of the data sets acquired with a pancake coil at 400 KHz was analyzed. Figure 1 is a terrain plot which is a part among several processing stages in MPA when analyzing defects. From Figure 1, two defects were confirmed to be detected. Two indicators of Cu and TTS which can be specified randomly by a user were used to identify the position of a defect. An exact defect information, however, may not be estimated accurately only by Figure 1. The defect depth or length can be analyzed by comparing many assessment results. Figure 2 is an image display and defect depth profile. To obtain a depth profile, the crossbar was usually positioned on defects that have the maximum depth. From the depth profile, it has 75% tube wall (TW) penetration in depth and 9.5 mm in length. It is difficult to obtain a depth profile when the defect shape is complicated. In this case, several results such as axial and circumferential direction profiles, 3D terrain plot were examined.

Figure 1 3D-terrain plot orienting from the ID of the tube A1

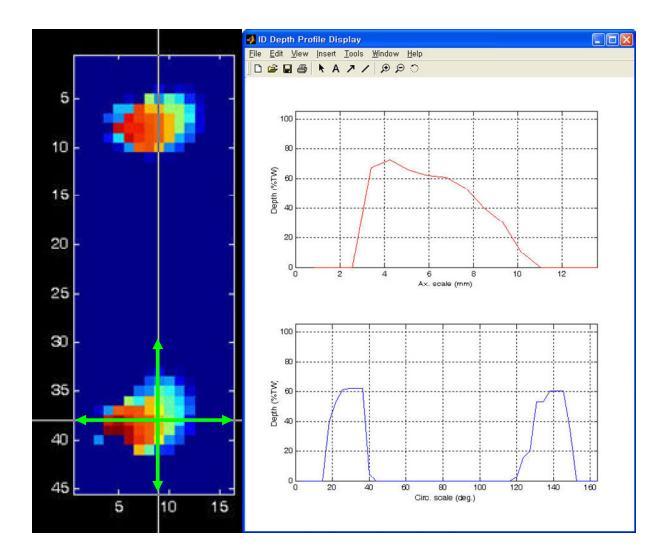
Figure 2 Image display and estimated depth profile by locating the cross-bar on the defect image.
