Proceedings of the Korean Nuclear Society Spring Meeting Pohang, Korea, May 1999

# Confirmation of Failure Causes of PWR Defective Fuels

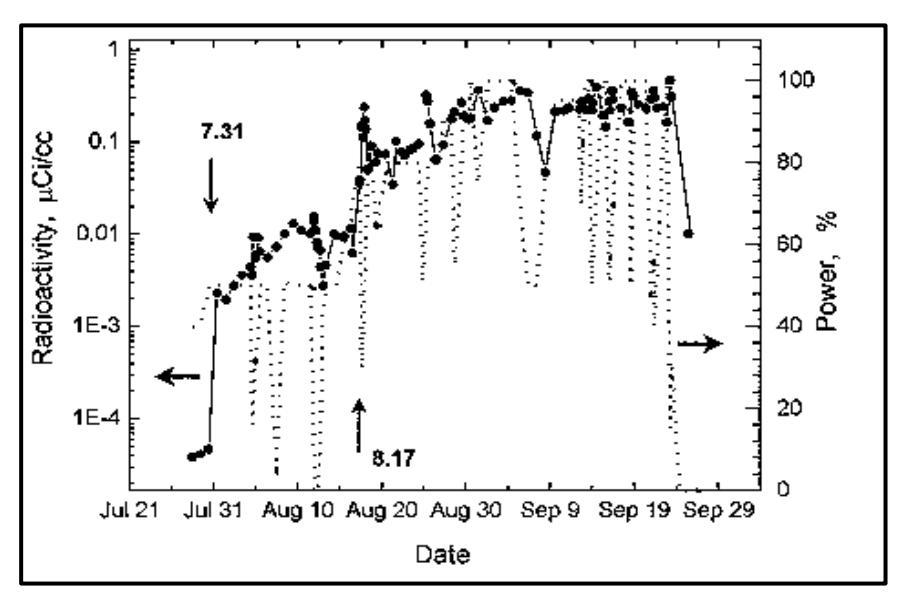
The plant fuel shows an abrupt increase in  $I^{131}$  release of about 1  $2x10^{-3} \mu$  Ci/cc, at the end of July 1995 just after 50% of plant power increment (Fig. 1). Since the failed fuel rods were both in the core periphery, it is unlikely that one non-fuel-releasing failure could release this much. Thus it is likely that the debris failure occurred at that time. This is supported by an observed continuing increase in the I<sup>131</sup> activity. On August 16, a very large further increase is observed. The plant power decreased from 80% to 30%, and about 40 times of Iodine activity increase was detected. This indicates severe degradation, i.e., the observed axial crack occurred, or expanded, at that time. It is not possible to tell when the second failure occurred, since it is overwhelmed by the fuel-releasing one. After the severe degradation, the fuel release did not worsen too much. However, the level of activity did not decrease, which indicates that either the fuel release had stopped and all released fuel was firmly settled on fuel surfaces elsewhere in the core, or the fuel kept releasing enough to keep up with the coolant cleanup system, which is only capable of removing contamination dissolved and suspended in the coolant. It should be conservatively assumed that the Iodine, after the restart, and off gas activities will remain high, despite the removal of the failed fuel. The I<sup>131</sup> level is 0.2 µ Ci/cc which shows an abrupt increase at the end of July, i.e., at the suggested time of the first fuel release. The ratio of  $I^{131}$  to  $Xe^{133}$  shows an EOC value about 0.3, which is equal to its "tramp" value. This indicates that the activity release is dominated by released fuel (tramp). The ratio  $I^{134}$  to  $I^{131}$  shows a gradual decrease between the suggested first incident of fuel release and the severe degradation on August 15. This indicates a widening of the breach in the fuel-releasing rod.

Fig.1. Coolant Radioactivity in NPP

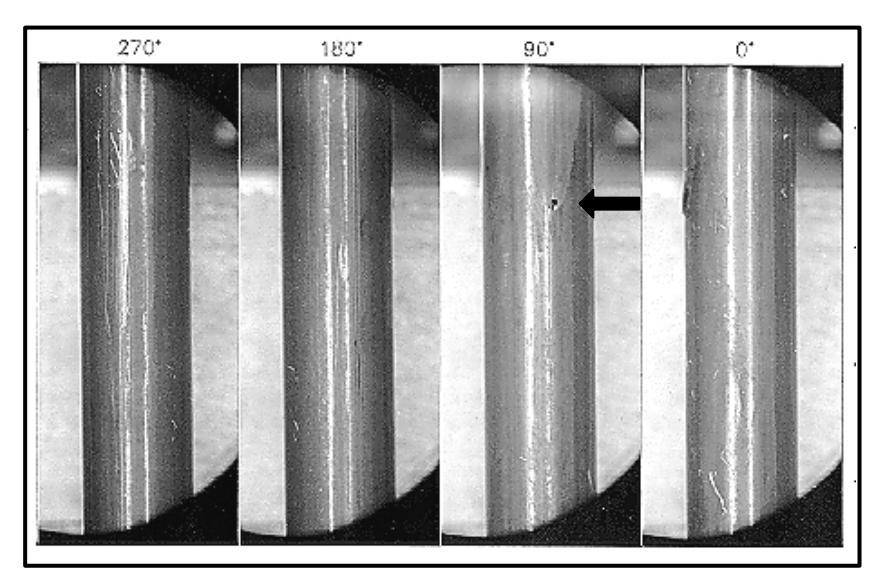
Visual inspection of R-rod indicated the presence of a small through-wall hole at approximately 93mm from rod bottom (Fig.2), which is located within the upper half of the bottom Inconel spacer grid. There is no evidence of any grid-to-rod fretting wear in this region. The through-wall hole, therefore, was most likely caused by a sharp piece of debris that became entrapped within the grid cell occupied by R-rod. This small through-wall site is believed to be the primary defect site. Additional areas of damage on the rod caused by secondary hydride failure were observed at 2,660 mm with a long axial crack below Zircaloy-4 Grid #7 and ghost hydride through Grid #7 region (Fig. 3) (1,2).

Fig.2. R-rod Image around 93 mm

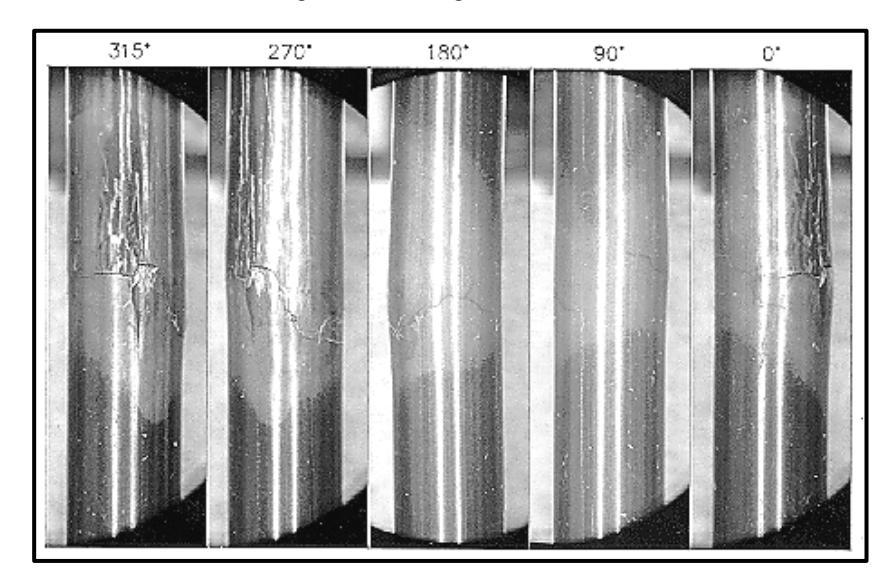
Fig.3. R-rod Image around 2,660 mm

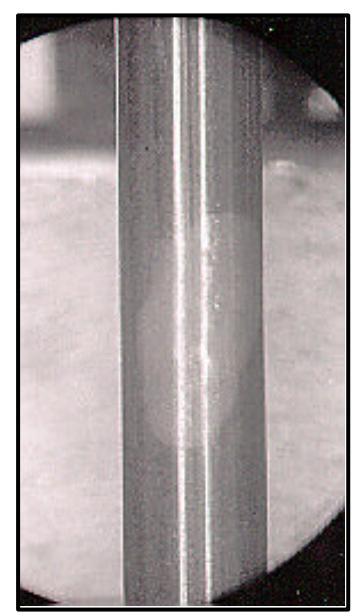
Visual inspection of K-rod indicated the presence of several regions of secondary hydride damage, but no indication of the location of the primary defect site. Ghost (white-colored) hydride regions were observed at 1,592 mm and 1,420 mm below Zircaloy-4 Grid #4. An open blister region was observed at 1,177 mm below Grid #3, with some material missing from a single fuel pellet visible at this location (Fig. 4, 5 and 6). A brittle region extended about 7.2 mm above the blister. Axial cracks were observed in this region, and some surface oxide and crud appears to be removed. An axial crack was also observed within the ghost hydride region at 1,592 mm. The visual inspection did not reveal any indications of fretting wear along the rod that could have been caused by either debris or grid-to-rod contact. Nor

Fig.4.K-rod at 1,420 mm

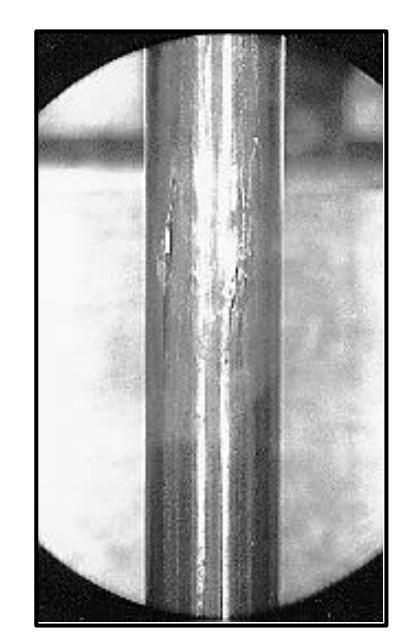
Fig.5.K-rod at 1,592 mm

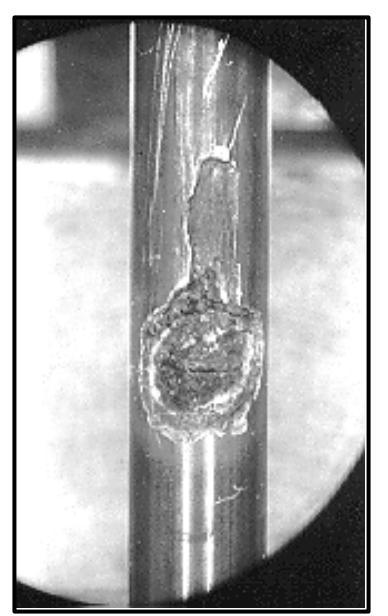
Fig.6.K-rod at 1,177 mm

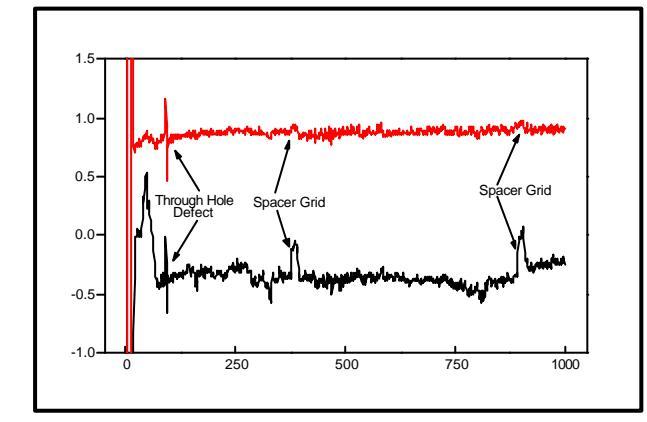
At first, for R-rod the orientation of fuel rod that was located in the assembly was determined and through-wall hole shape and dimension were inspected. Defect sizes measured were 0.9 mm and 0.3 mm in length and width, respectively. The defect locates at 93.2 mm from the bottom end of rod and was rotated about 70.3 ° from the front view. Eddy current test was conducted and no other noticeable defect signal was found except the defective zone(Fig.7). In X-ray radiography, no noticeable changes were detected and gamma spectroscopy result shows normal irradiation conditions (Fig. 8). And the vacuum leakage test for the end cap zone of the rod showed no leakage in both ends. In destructive test for R-rod,

Fig.7. ECT Result for R-rod

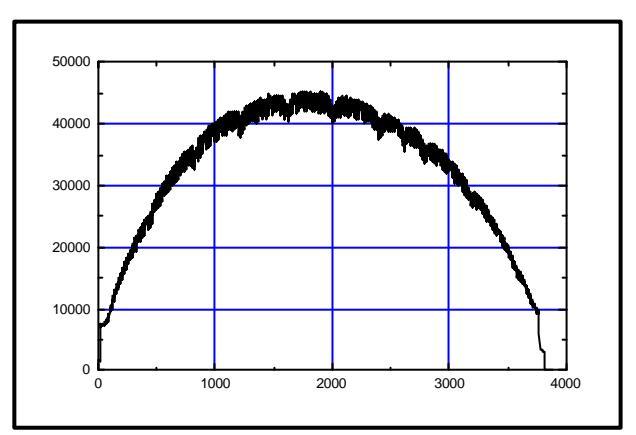
Fig.8. Gross Gamma Scanning Results of R-rod

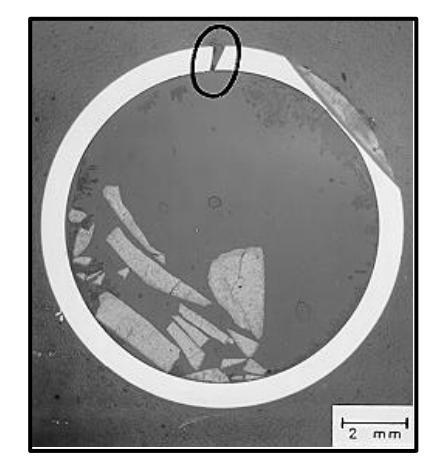
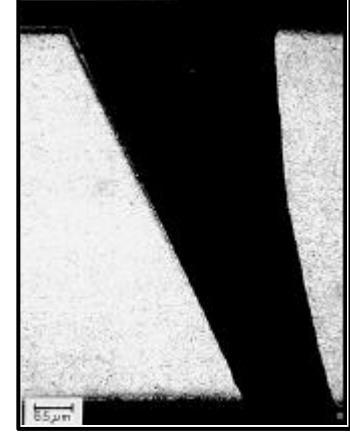
macro- and micro-structure of the pellet and cladding tube around defective area were examined precisely (Fig. 9 & 10). Inside and outside oxide layer thicknesses of the cladding tube around through-wall hole area were measured. About 10  $\mu$ m of oxide was measured around the grid spring contact area and about 4  $\mu$ m of oxide thickness was measured around the through-wall hole defect. The internal oxide thickness is about 4 5 times thicker than the external ones. While the external oxides layer distributions show almost uniform states with around 2  $\mu$ m of thickness, the internal oxides shows maximum 10.5  $\mu$ m of measured value at 2,100 mm location (Fig. 11). The oxide thickness of internal clad shows a little bit higher values which means that the failure of this rod was made comparably earlier time of BOC. It is reported that the normal irradiated intact fuel used to show little oxide layers in internal clad surface(4).

A precise PIE for the R-rod shows that the failure of this rod was oriented from the debris induced fretting mechanism made by a foreign materials with very sharp and hard end tip. A very hard and sharp tip of debris trapped in the first spacer grid spring shell made a continuous pressure onto the fuel cladding tube until the through hole debris induced fretting failure was made. This is the primary root cause of failure of R-rod.

Fig.9. Thru-Hole Defect of R-rod

Fig.10. Thru-Hole Defect

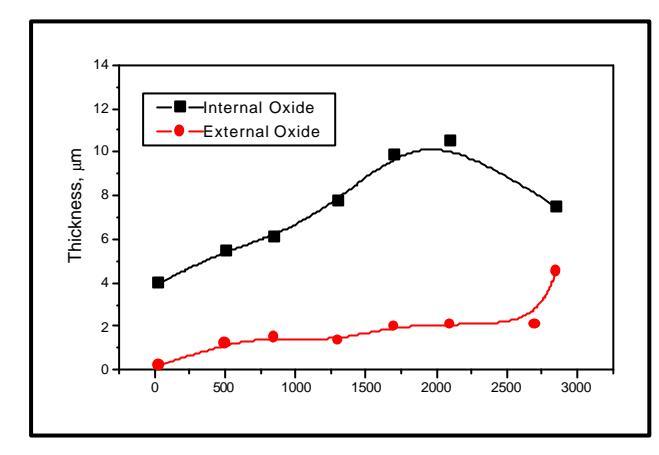
Fig.11. Oxide-Layer Thickness of R-rod

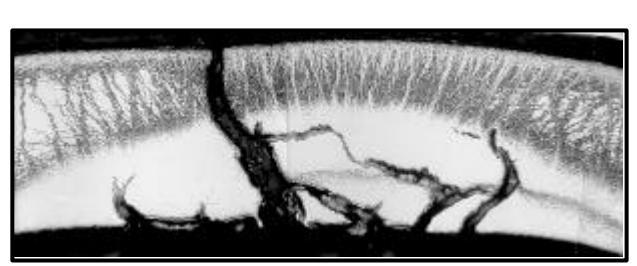
Fig. 12 shows a typical secondary hydride failure of R-rod located at 2,660 mm from the bottom end of rod. And the density of fuel pellet is 10.535 10.567 g/ $cm^3$  which shows very small discrepancies with the fabrication data of 10.55 g/ $cm^3$ . It was expected from the burn-up measurement result of this rod and the measured burn-up was about 2,013 MWD/MTU.

Fig.12. Secondary Hydride Failure of R-rod

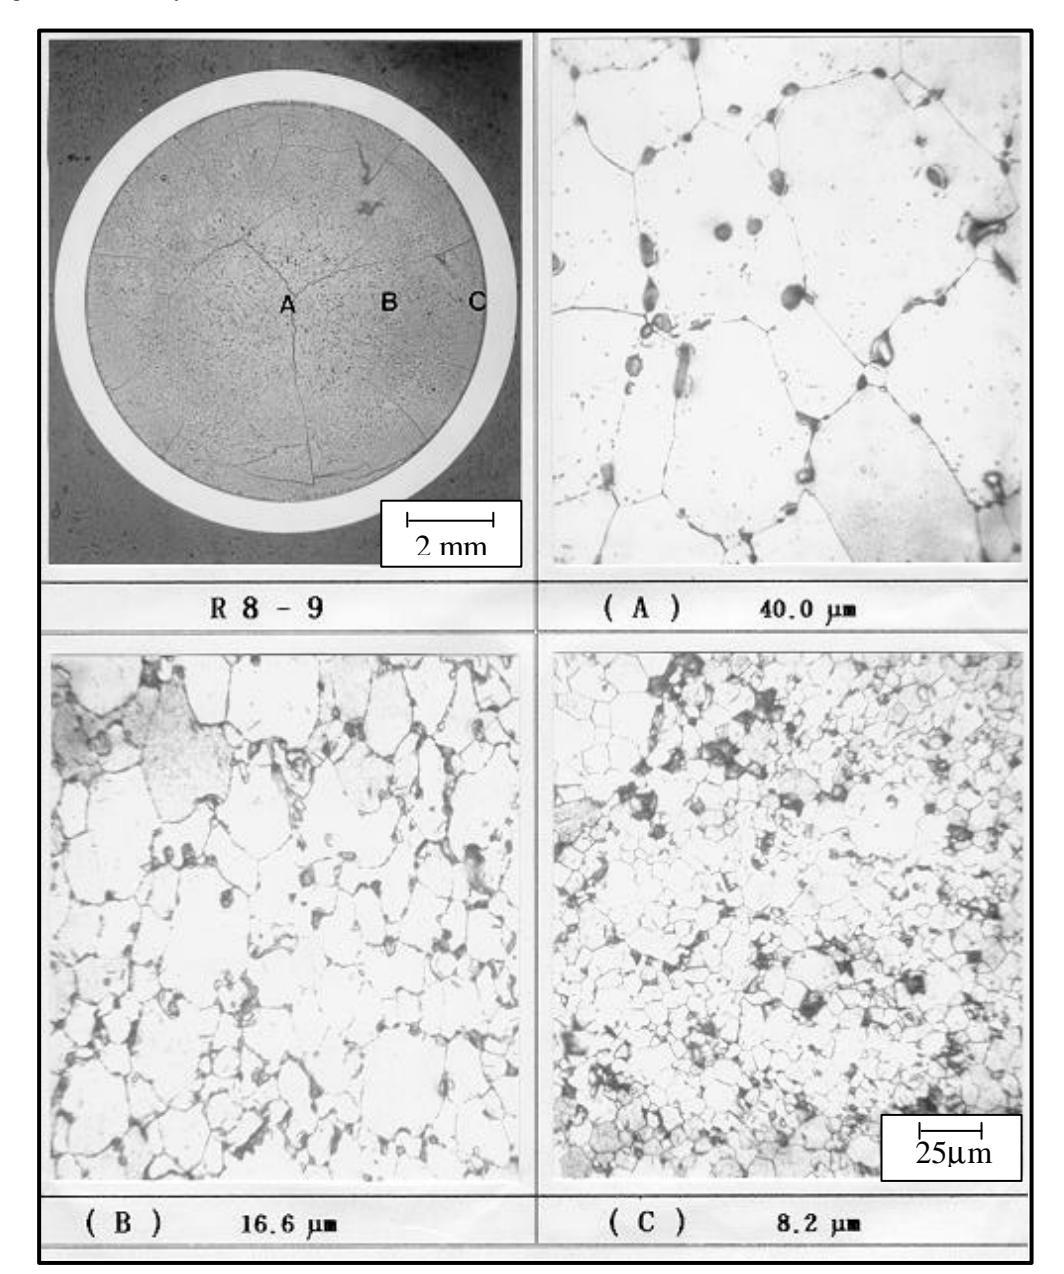
The macro- and micro-structure of R-rod showed similar structures to the un-irradiated  $UO_2$  structure except for the region between 1,300 2,120 mm where remarkable grain growth phenomena were shown(Fig.13). It is believed that the intrusion of coolant through the defect led to the oxidation of fuel pellet. Consequently, the O/U ratio increased which lowered the thermal conductivity of fuel and it finally contributed to the raising of fuel temperature up to the temperature point enhancing the grain growth of  $UO_2(5)$ .

Fig.13. Macro- and micro-structure of Fuel Pellet of R-rod at 2,100 mm

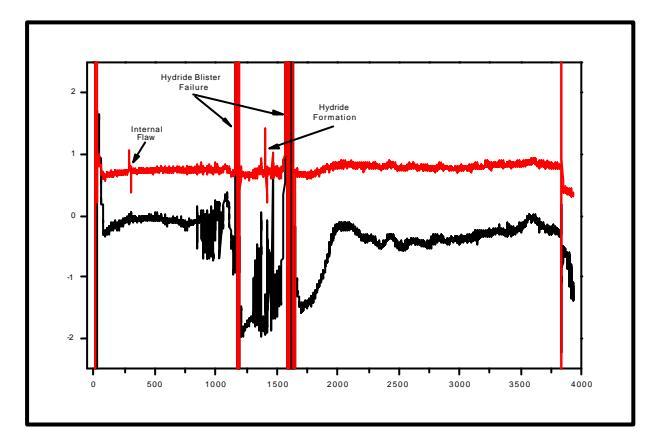
In K-rod, there are 4 suspicious regions showing extraordinary signals or results through NDT examinations. Cladding failures were observed around 1,177 mm and 1,592 mm region. Between two locations, ECT (Eddy Current Test) signal of a large defect was detected at 1,420 mm location, and finally internal flaw signal was detected at 276 mm, but the magnitude was comparatively small (Fig. 14). X-ray radiography shows a normal stack states of fuel

Fig.14. ECT Result for K-rod

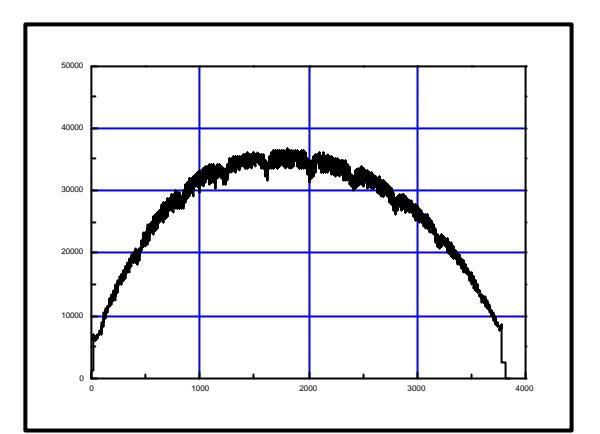
pellet. The gap interfaces between pellets were maintained in normal states. The average diameter of the fuel rod was  $9.70 \pm 0.02$  mm, and ovality conditions of the clad show normal states except the region around the hydride failure occurred. Gamma scanning examination was carried out to gather the irradiation information of fuel pellets by collecting the gross and specific gamma counts for several isotopes such as Cs, Nb and Zr (Fig. 15).

Fig.15. Gross Gamma Scanning for K-rod

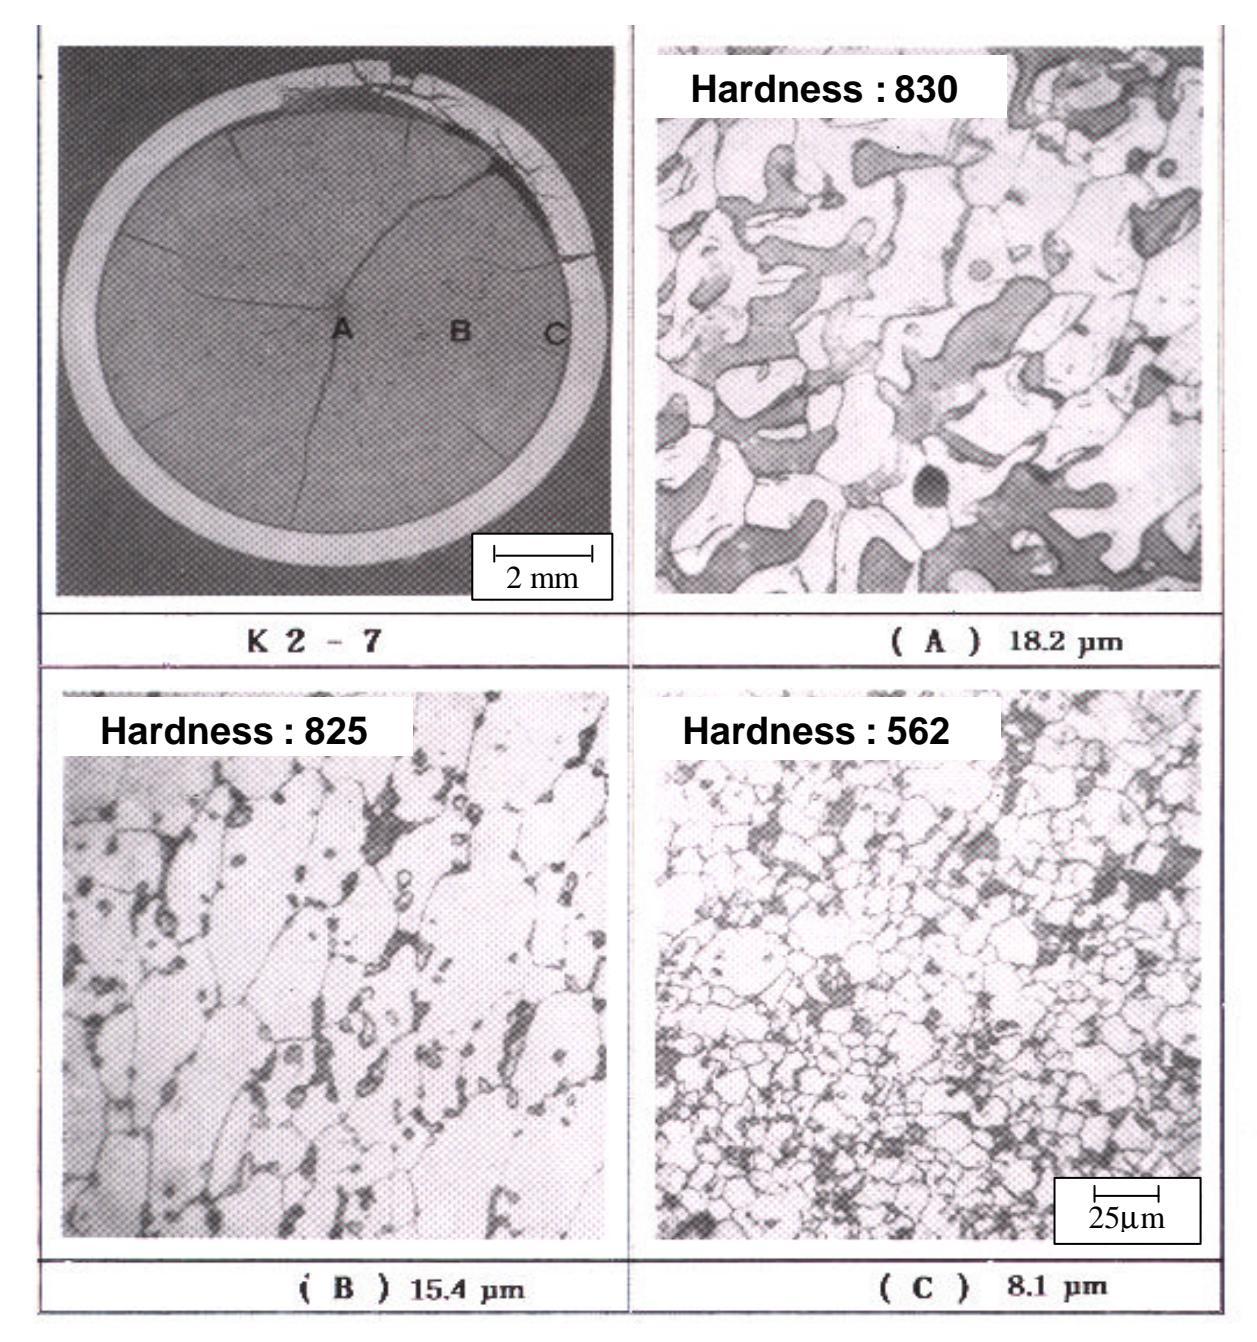
Microscopic examination of fuel pellet of K-rod was performed by selecting several specimens from the rod (Fig.16). The micro-structures of the pellet irradiated at the lower part of fuel showed about 8 µm of grain size, and the structure of the whole area showed very similar results to the un-irradiated ones. But the structure between 810 1,580 region shows a little bit bigger grain growth rather than that of the normal irradiated fuel pellets. And a large concentric ring type of grains seen in the middle of fuel pellet was identified as a agglomeration of columnar grains which were believed to be formed by the subsequent mechanisms of stoichiometry changes of UO<sub>2</sub> affected by the coolant intrusion. It is reported that the increasing of O/U ratio up to 2.1 used to directly contribute to about 40% of thermal conductivity reduction. These postulations can be supported by the hardness test results of pellet. Fig. 16-a and 16-b show the micro-hardness distributions. Fig. 16-b shows a little bit higher hardness numbers than the ones of 16-a, which means the increasing of O/U ratio due to coolant intrusion and subsequent oxidizing of  $UO_2$  were made in comparatively high temperature environment. The dark area showing about 30 of hardness number are the resin mount which are penetrated through the pores in the center part of pellet during specimen preparation. A large amount of pores possessed by the resin mount can explain that the temperature of this region was very high compared to the other clean area of fuel rod.

Fig.16.Micro-hardness results of K-rod at 1,580 mm

(cf. Unirradiated  $UO_2$  Pellet Hardness : 407)
