Defect detection and cause analysis of HANARO research reactor fuel fabrication

Research Reactor Fuel Division, Korea Atomic Energy Research Institute, 111, Daedeok-daero 989beon-gil, Yuseong-gu, Daejeon, Republic of Korea *Corresponding author: wjso@kaeri.re.kr

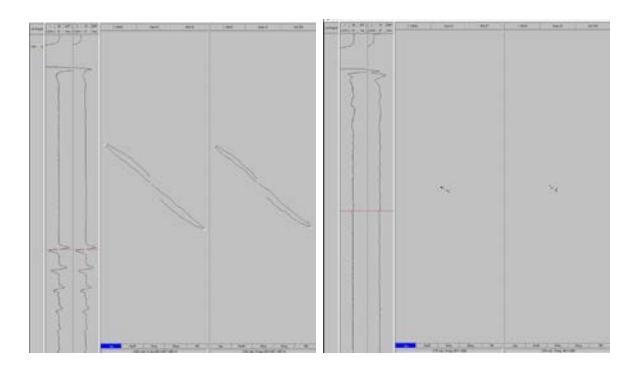
Surface scratches, pinholes, blisters, dents and foreign particle inclusions can arise in the cladding during the cladding co-extrusion process. An eddy current test (ECT) can detect defects on the surface or below the surface of the 0.75 mm thick Al cladding [1]. Every fuel rod passes through a probe to record ECT signals of the cladding. The types and sizes of the defects are then interpreted through a comparison with the signals from a standard specimen with artificial defects. Fig. 2 presents an example of a fuel rod that

failed to meet the acceptance criteria due to a surface scratch in the cladding, and Fig. 3 visually illustrates the defect in this case. Such fuel rods with defects are inspected again after removing defected cladding and re-clad.

Fig. 2. Comparison 15 kHz and 30 kHz ECT signals of a standard specimen (left) and a fuel rod (right)

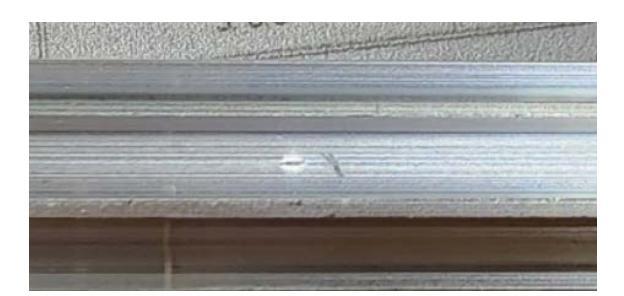
Fig. 3. Scratch on the surface of the cladding

Cladding defects of this type may be due to foreign substances in the mix or may stem from an air layer that was trapped in the cladding and burst during the coextrusion process. Therefore, it should be considered to check the impurities in the cladding material and the cleanliness of the extrusion mold.

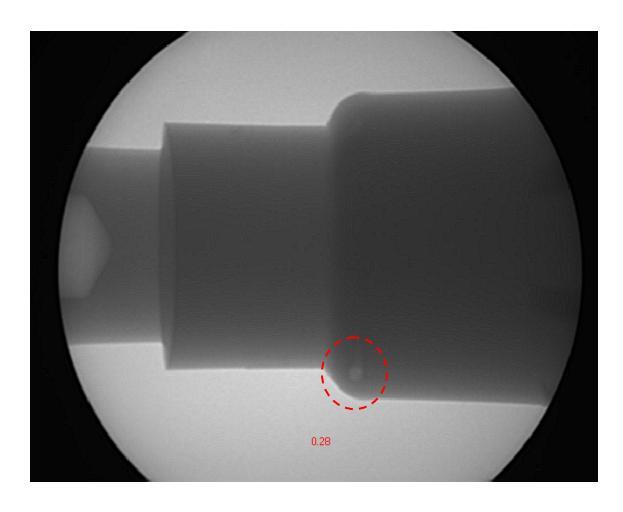
The most common type of defect is a blowhole. The material of end-plug and cladding is both pure aluminum and when a high-energy electron beam is concentrated in a very thin area, blowholes can be generated in the weld [2]. According to the specifications in the HANARO fuel manufacturing instructions, the number of pores should be less than 5 and the sound bead depth should be at least 0.33 mm [3]. Fig. 5 shows an example of a blowhole in the weld. The thickness of the weld of this fuel rod is 0.28 mm, and it did not meet the acceptance criteria.

The main causes of such blowholes being generated in the weld are an inappropriate EB welding setting (e.g., voltage, current, welding speed) or an improper thermal diffusion effect. The EB welding machine currently used for HANARO fuel manufacturing is a newly introduced equipment, and through the further studies that analyze the heat sink designs of this device, it is expected that the generation of blowholes could be suppressed by controlling the thermal diffusion effect.

Fig. 5. RTR of a blowhole in the weld

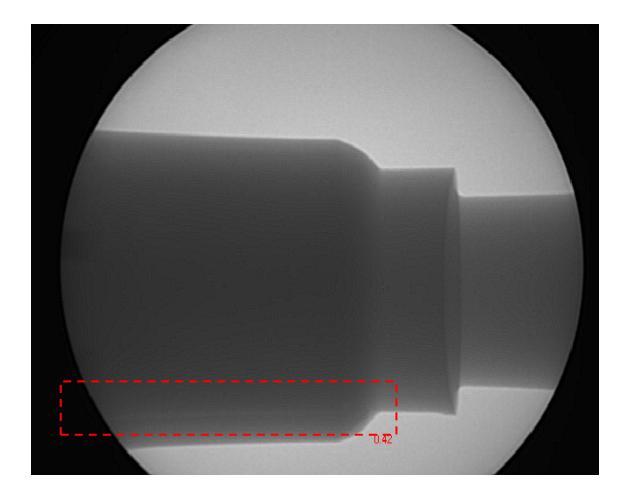
Another form of defect is a gap defect. A gap defect refers to a defect in which the cladding is not in close contact with the end-plug, being instead slightly separated. These are indicated by a bright line on the RTR inspection screen. Fig. 6 shows a gap defect in a fuel rod.

The end-plug hole machining process could cause gap defects. If there is an air layer between the end-plug and the machined insertion hole in the fuel core, the gas can expand during EB welding and diffuse to the endplug cladding boundary layer. Another possible cause of such a defect is deviated straightness of the fuel rod, a problem that arises after the co-extrusion process. If fuel core is bent, the cladding may float slightly over the fuel core after co-extrusion. Therefore, it is necessary to consider whether the straightness calibration of the fuel core is properly performed.

Fig. 6. Gap defect between an end-plug and the cladding
