Effect of dissolved oxygen on SCC of LP Turbine steel

(Slow Strain Rate Test)

3.5NiCrMoV

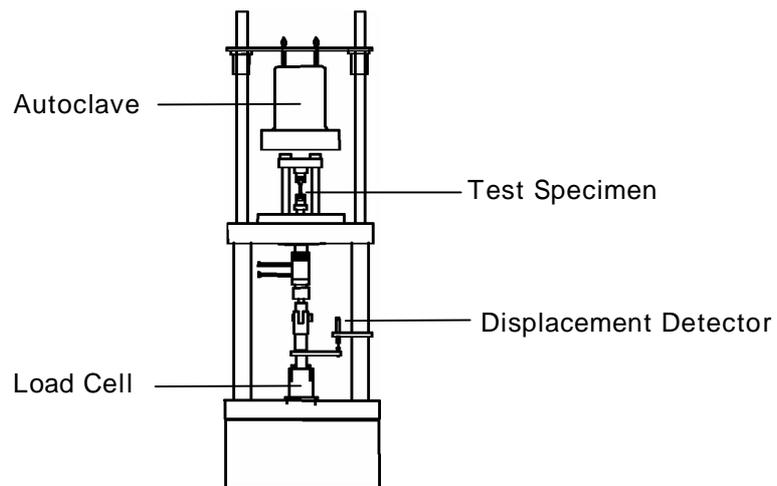
Fig. 1. Schematic drawing of the slow strain rate tester.

3.78 Hastelloy C-276 (autoclave) (slow

strain rate technique ; SSRT) . 1 CERT

Toshin Kogyo Co, Ltd. SERT-C-5000 .

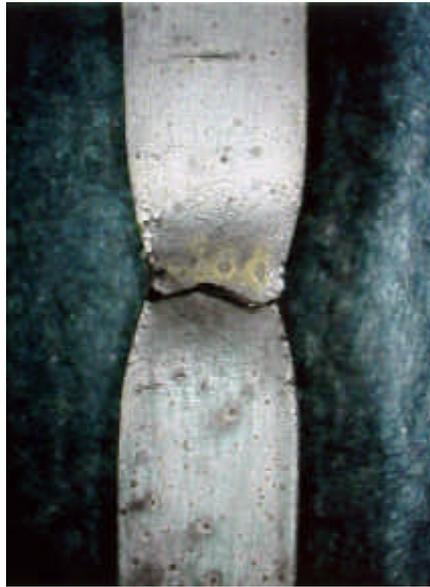
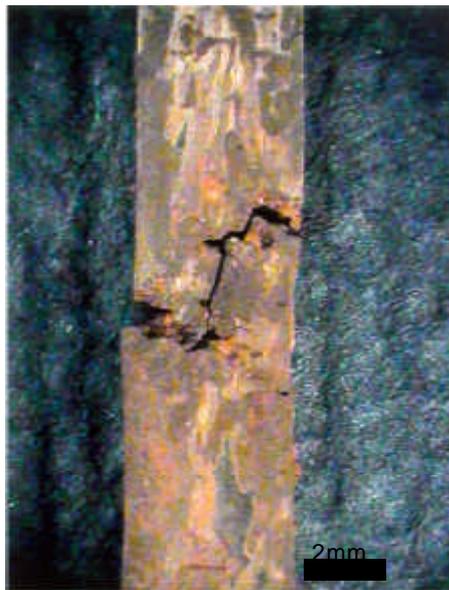
Fig. 4. Fracture morphologies tested in varied environments with the strain rate of 10^{-7} s^{-1} at 150 °C; (a) deaerated water, (b) intermediated, (c) aerated water.

3.85 , 625(Inconel 625)
 Alloy 600 (lead wire)
 Teflon tube (reference electrode) Ag/AgCl
 (counter electrode)
 1200 grit . 2
 가 3 2 /min
 -0.7V(vs. Ag/AgCl) (+) 0.1mV/s
 1.4V , EG & E Model 263A potentiostat
 Ag/AgCl
 3.
 3
 150 10^{-7}s^{-1}
 2
 14%
 11% 6% 761MPa
 745MPa 714MPa
 가
 SEM 3 (a) (b)
 (dimple)
 (cup-and-cone) 4(a)
 가 3(c)
 (dimple)

가 . 4(b)

, (necking)

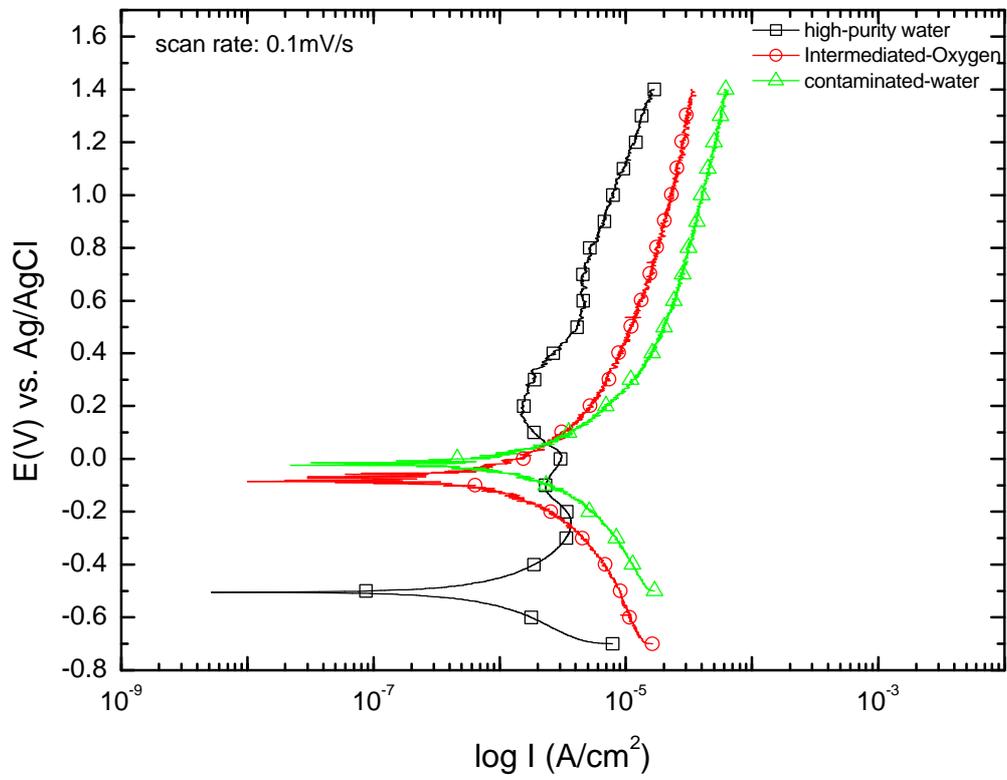
Fig. 5. Polarization curves of 3.5NiCrMoV steel in varied environments at 150 : scan rate-0.1mV/s.

5

-21mV(vs. Ag/AgCl)

-75mV

-505mV

1460 nA/cm²

772 nA/cm²

420 nA/cm²
