## Experiment on the Shear Capacity of M12 Concrete Expansion Anchors Installed in Low Strength Uncracked Concrete with various Torque

\***Keywords** : concrete expansion anchor, shear strength, installation torque, experiment

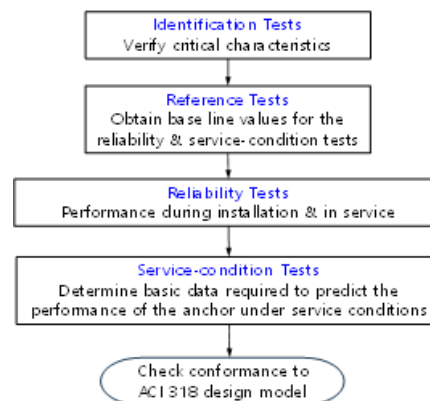
For testing, the methods of ACI 355.2 and ASTM E488 [3] were applied. The test follows the testing program as shown in Figure 1. Loading was applied by a hydraulic cylinder. The displacement was recorded by using a linear variable displacement transducers (LVDTs), and loads were measured using a load cell. The loading was applied until concrete failure.

Fig. 1. Testing program for post-installed mechanical anchors in concrete (ACI 355.2, 2001)

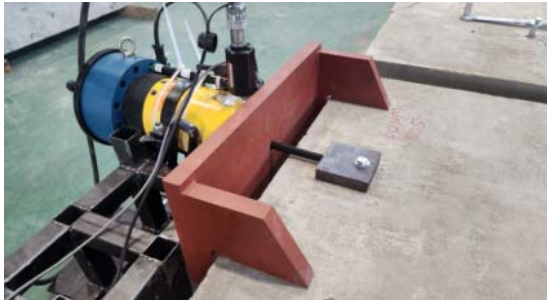
The test set-up is shown in Figure 2. The test fixture on the concrete blocks was fabricated according to ASTM E488 [3]. The jig size was determined to be sufficient to prevent interference with adjacent failure circles. Three anchors were installed on a single concrete block.

Fig. 2. Test set-up for shear test

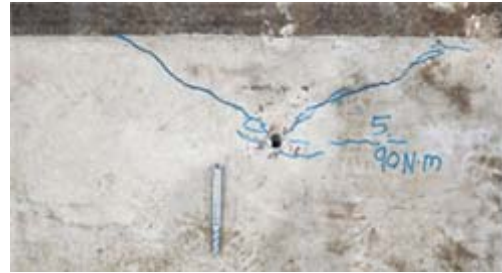
The test results were summarized in Table 3. The coefficient of variation (COV) ranged from 4.3% to 8.8%, indicating low variability among the five test specimens. The standard installation torque case produced the highest mean peak load. The shear capacity shows no noticeable change depending on the torque value. Figure 3 shows the load-displacement curve recorded in the standard torque case test. The failure mode is mostly concrete breakout. Figure 4 shows the failure mode of concrete breakout.

Fig. 4. Concrete breakout failure

This study experimentally investigated the shear performance of CEA installed with different torque. The test results show that the magnitude of the installation torque does not significantly affect the shear performance of CEA, which is tightened with a force up to 200% of the standard torque. After concrete breakout occurred in the shear test, a continuous load caused the concrete pry-out in the opposite direction of the loading direction. Excessive tightening can cause sleeve rupture when installing anchor bolts.
