Database development on SCC from a retired steam generator

Seong Sik Hwang*, Jangyul Park, Hong Pyo Kim

Korea Atomic Energy Research Institute, 1045 Daeduckdae-ro, Yuseong-Gu, Daejeon 305-353,

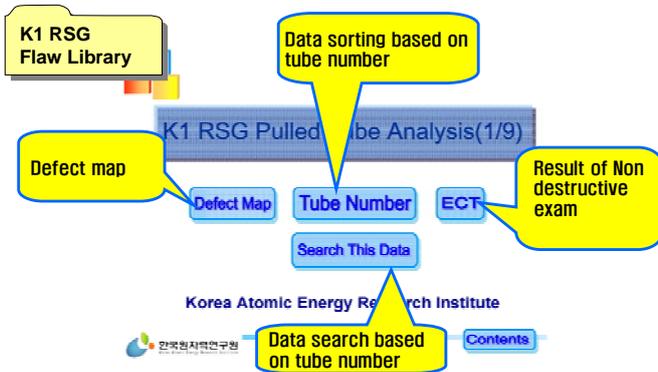
Fig. 4 Main frame of the SCC flaw database library

Based on the metallographic examination on the 91 sections of the tubes, a database was developed as shown in Fig. 4.[2]

Detail flaw information can be searched based on a tube number, tube location or based on ECT results. Crack length and location can be compared with ECT results. The detail crack information was transferred to the other group in order to develop a better in service inspection technology.
