Characteristics of SCC Defects of Retired Steam Generator

Seong Sik Hwang, Man Kyo Jung, Hong Pyo Kim, Joung soo Kim
Korea Atomic Energy Research Institute, 150 Deokjin-dong Yuseong-Gu, Daejeon 305-353, Korea
sshwang@kaeri.re.kr

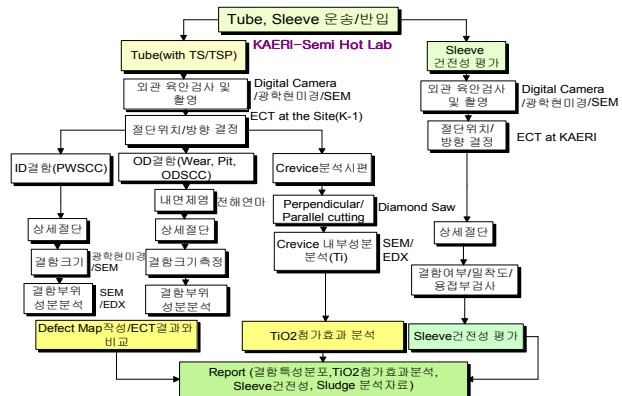
Fig.1 Flow chart of defect analysis

Tubes extracted from a retired steam generator based on ECT at the site were transferred to the hot laboratory of KAERI. Detailed nondestructive analysis examinations for marking of the defects were taken, and metallographic examinations were carried out in a hot cell. Types and sizes of the defects were characterized by using a high magnification contact camera and scanning electron microscope(SEM), and chemical compositions out side of the tubes was also measured by using EDS. All the crack information was compiled in a database, and a relationship among SCC defect location, defect depth, and sludge height was obtained. Fig 1 shows the analysis procedure on the SG tubes.
