## Effect of the Molten NaCl-MgCl<sub>2</sub> Salt on the Corrosion of 316 Stainless Steel

Hwa Jeong Han<sup>a</sup>, Hyunjin Boo<sup>a</sup>, Jonghyeon Kim<sup>a</sup>, Su Hyeon Lee<sup>a</sup>, Su Hyeon Kim<sup>a</sup>, Byung Gi Park<sup>a\*</sup>

<sup>a</sup>Department of Energy and Environmental Engineering, Soonchunhyang University, 22 Soonchunhyang-ro, Asan-si, Chungcheongnam-do, 31538, Republic of Korea

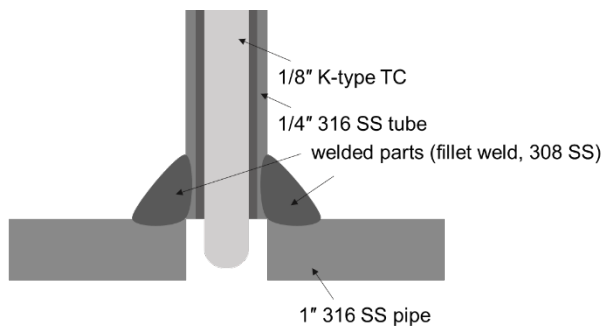
The 1/4-inch tube was fillet welded above the perforated 1-inch pipe with gas tungsten arc weld (GTAW) using a 308 stainless steel welding rod. Fig. 1. shows the schematic of the fillet weld used GTAW.

Fig. 1. the schematic of the fillet weld used GTAW.
