Analysis of Unplanned Shutdown in HANARO: Thermal Analysis of Thermal Overload Relay for Shutoff Rod Pump Motor

Hun Young Kim*, DongHyuk Lee

Korea Atomic Energy Research Institute, 111, Daedeok-daero 989 Beon-gil, Yuseong-gu, Daejeon 34057, Korea

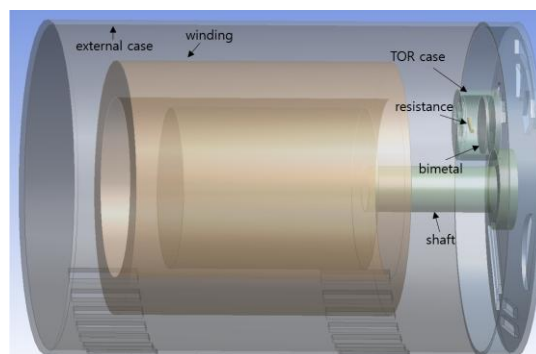
To evaluate the thermal behaviors of the TOR within pump motor, a three-dimensional numerical model was simulated using ANSYS Fluent v16. The model encompassed the major components of the motor, including the external case, internal windings, shaft, and the TOR assembly consisting of the bimetal, resistance heater, and its protective case. The components of the model are shown in Fig. 1.

Fig. 1. The components of the pump motor in the model.
