Measurement of Coolant Leakage from Lab Grown Axial Crack of SG Tubes

Seong Sik Hwang, Dong Jin Kim, Man Kyo Jung, Hong Pyo Kim, Joung soo Kim
Korea Atomic Energy Research Institute, 150 Deokjin-dong Yuseong-Gu, Daejeon 305-353, Korea
sshwang@kaeri.re.kr

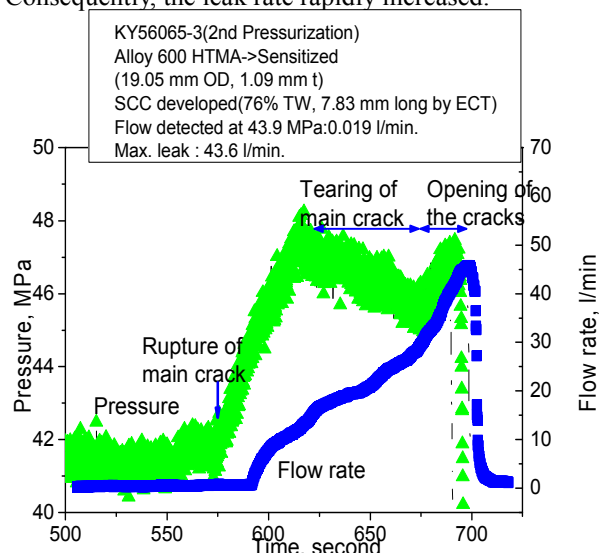
Fig. 2 is a typical behavior of the pressure and leak rate during the water pressurization on a SCC degraded tube. In the case of KY56065 specimen, the main crack opened at 42 MPa and leakage was begun to be recorded. As the pressure increased, the crack opening increased also. It was torn largely at 48 MPa, the water pressure decreased while the flow rate increased. A further increase of water pressure at the test time of 670 seconds enabled the crack to open largely. Consequently, the leak rate rapidly increased.

Fig. 2 Leak behavior from a SCC degraded tube at room temperature.

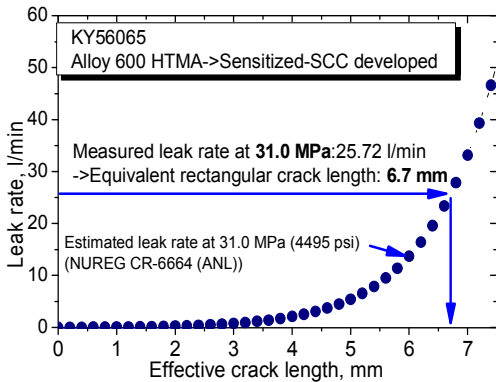
A leak rate measured and estimated based on the leak rate model[4] is shown in the Fig. 4. In this test, a measured leak rate of 25.72 l/min at 31 MPa corresponds to an equivalent crack length of 6.7 mm which is calculated from the leak rate model. Then the length of main crack after the burst is 5 mm, and there are multiple cracks, of which lengths are 1 mm to 5 mm as shown in Fig. 3. Since the cracks are not single manner, it is hard to compare the measured crack length with the estimated one.

Fig. 4 Comparison on leak rate measure and estimated based on the leak rate model

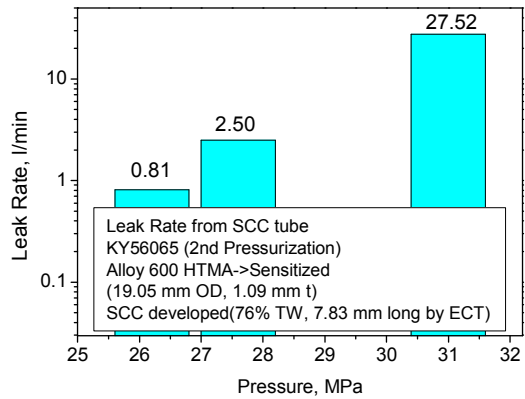
The tube showed different leak rates depending on the internal water pressure as depicted in Fig. 5. When considering a pressure difference of 8.5 MPa between primary and secondary side of the SG tubes, the leak rate of 0.81 l/min at 26 MPa is not so big. It can be said that multiple cracks of over 5 mm long on a tube do not show the EPRI leakage guide line action level 1(78.85 l/min)

Fig. 5 Dependence of leak rate on pressure of a SCC degraded SG tube
