# Burst pressure and leak rate from fretted SG tubes

Seong Sik Hwang, Man Kyo Jung, Hong-Pyo Kim, Joung soo Kim  
Korea Atomic Energy Research Institute, 150 Deokjin-dong Yuseong-Gu, Daejeon 305-353, Korea  
[sshwang@kaeri.re.kr](mailto:sshwang@kaeri.re.kr)

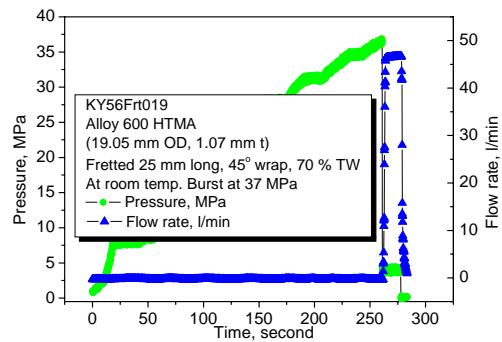
Fig. 2 Burst pressure and leak rate of a fretted tube(KY56ftr019)

Fig. 2 is a typical behavior of the pressure and leak rate during the water pressurization on a fretted tube specimen. The tube of which the defect depth is 70% of the tube wall(TW) showed a burst pressure of 37 MPa. The pressure is much lower than that of the unflawed tube;66.9 MPa[3].

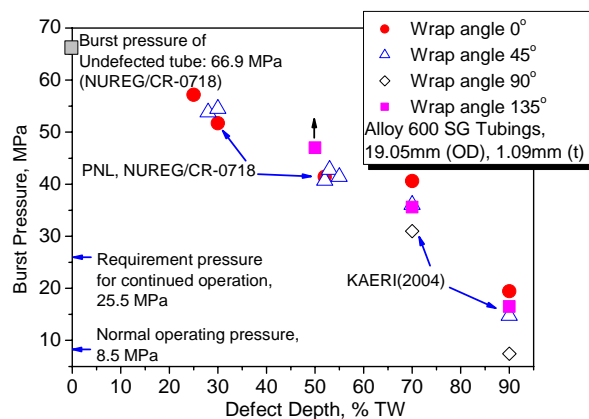
Fig. 3 Effect of defect depth on burst pressures of fretted tubes

Burst pressures of the tubes having different defect depth and different wrap angle are shown in Fig. 3. Burst pressures of 30~ 40 MPa were obtained for the tubes of 70 % TW defects. For the tubes of 90% TW defects, burst pressures of 15~ 20 MPa were recorded, which are higher than

that of a pressure difference of the normal operating pressure difference between the primary and the secondary side of the tube. The burst

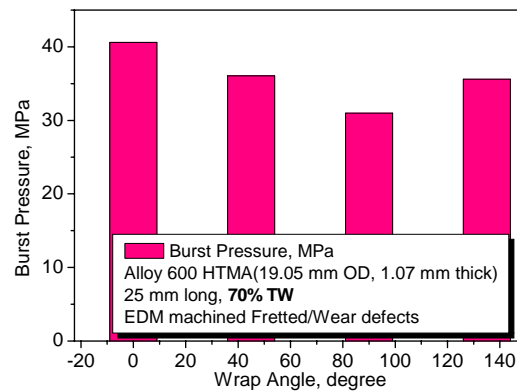
Fig. 4 Effect of wrap angle on the burst pressure of fretted tubes

pressure showed a wrap angle dependency as indicated in Fig. 4; as the angle increased, the pressure decreased with an exception of a 135 degree of the wrap angle.
