High Ca-Hardness Treatment Program of Secondary Cooling System in HANARO

Abstract

The secondary cooling water in HANARO had been treated with a low ca-hardness treatment program. The program has now been altered to a high ca-hardness treatment program to reduce the consumption of service water and the maintenance cost. After the alteration of the water treatment method, the water quality of the secondary cooling system is maintained below the limit of water quality control as same as before the alteration. This means indirectly that the secondary cooling system is not much affected by the water quality. To confirm this fact, it is necessary to analyze the effects of corrosion, scale, sludgy and slime that the water qualities are directly interfered with the secondary cooling system. We analyzed the deteriorating effects with a water monitoring equipment connected to the secondary cooling system to measure the monitoring parameters every 6 months. As a result, it is confirmed through this examination that the effects are maintained below the control limits and the high ca-hardness treatment program is applicable to treatment of the water quality of the secondary cooling system in

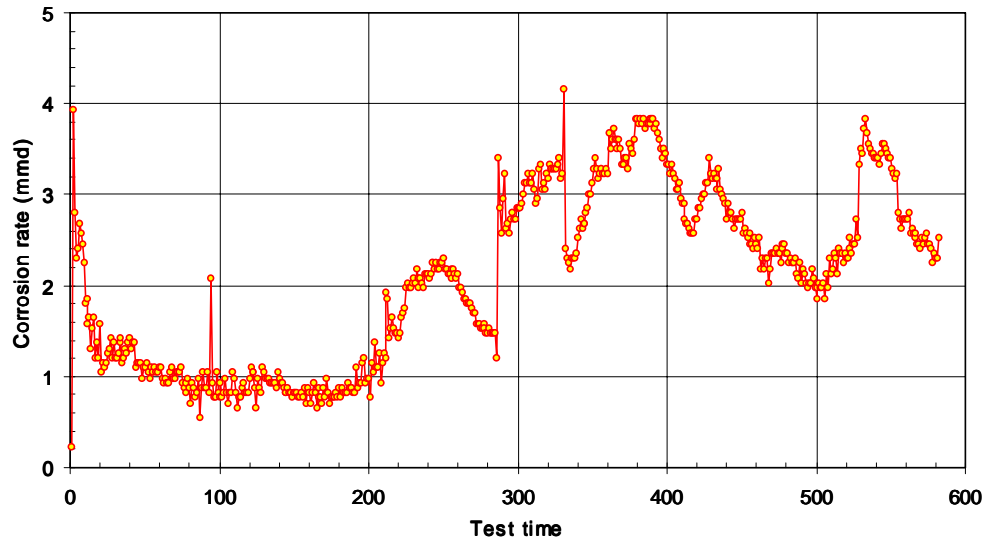
Fig. 5 Corrosion Rate

Description	Control Limit	1 st Test	2nd Test
Corrosion Rate (mmd)	20 >	1.83	2.18
Fouling Factor (kcal/m ² h)	5 x 10 ⁻⁴ >	4.9216 x 10 ⁻⁵	3.5 x 10 ⁻⁵
Bio-fouling	0.01 >	9.68 x 10 ⁻³	7.54 x 10 ⁻³
No. of Microbe (EA/ml)	10 ⁴ >	10 ⁴ >	10 ⁴ >
Turbidity (deg)	20 >	2	2.2

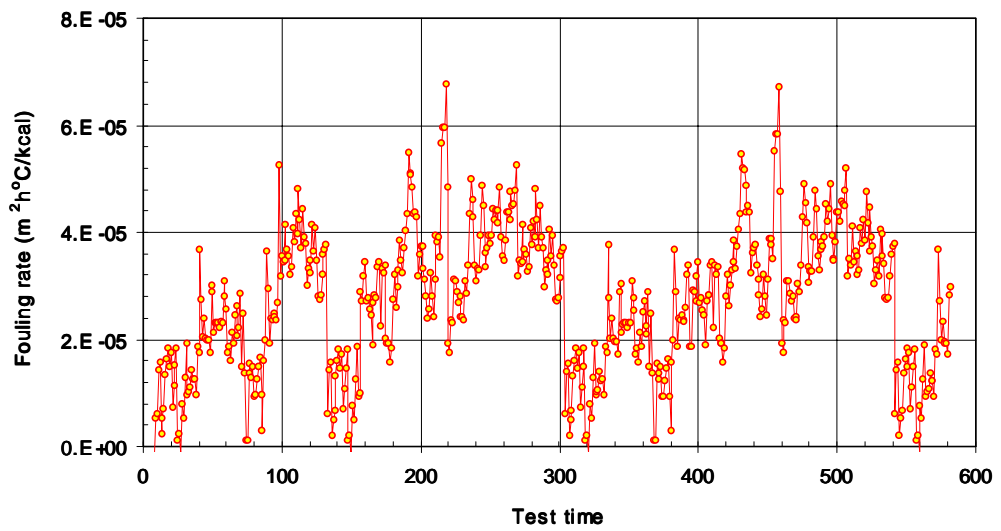
Fig. 6 Fouling factor

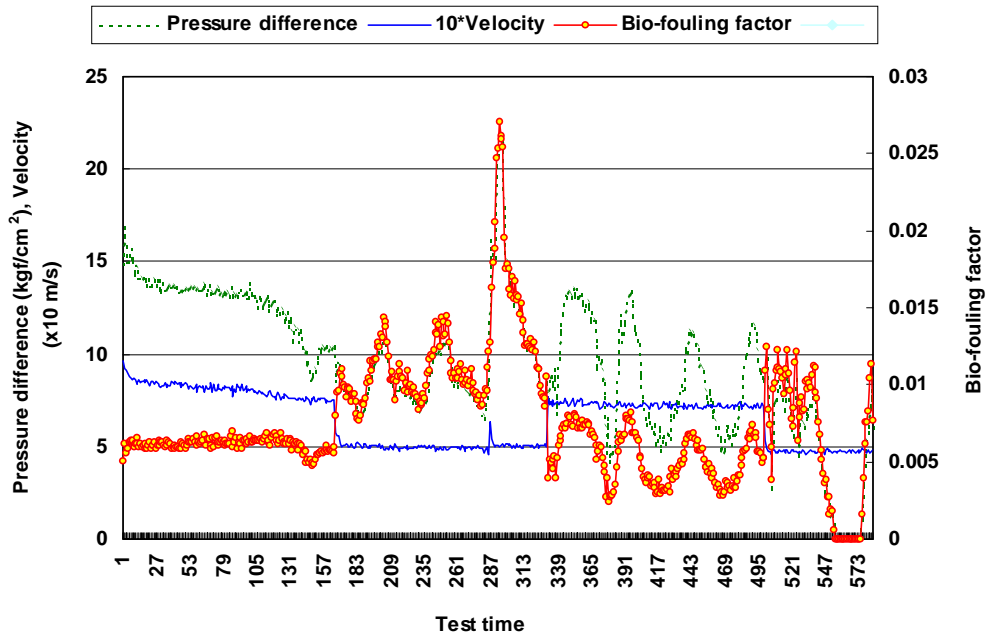
Fig. 7 Bio-fouling Factor
