Behavior and Response Capability of CANDU 6 NPP at Shutdown Condition during Extended Loss of All AC Power

Kyung Jin Lee^a, Seo Bin Oh^a, Su Hyun Hwang^a, Duck Joo Yoon^b, Seung Chan Lee^b

^aFNC Technology Co., Ltd., 32 Fl., 13 Heungdeok 1-ro, Giheung-gu, Yongin-si, Gyeonggi-do, Korea

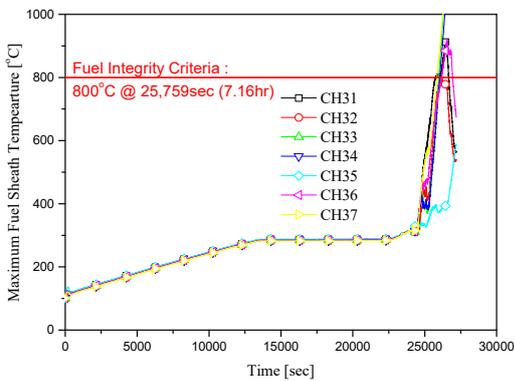
Fig.3. Fuel Cladding Temperature (case A)

The cladding temperature increases and exceeds the integrity reference value of 800°C at about 7.2hr as shown in Figure 3. Also the pressure tube temperature exceeds 600°C at which the tube is damaged.

the damage of the pressure tube occurs within about 7 hours. However, if the operator acts appropriately with available measures, the plant cooling could be maintained without the core damage.
