A Study on the Possibility of End-Fitting and Outlet Feeder Oxidation during Large Break LOCA with ECCS Impairment

Bo W. Rhee^{a*}, Y.M. Song^a, J.H. Bae^a, S.R. Kim^b

^aThermalhydraulics and Severe Accident Safety Research Division, KAERI,
989-111 Daedeok-daero, Daejeon, South Korea, 34057

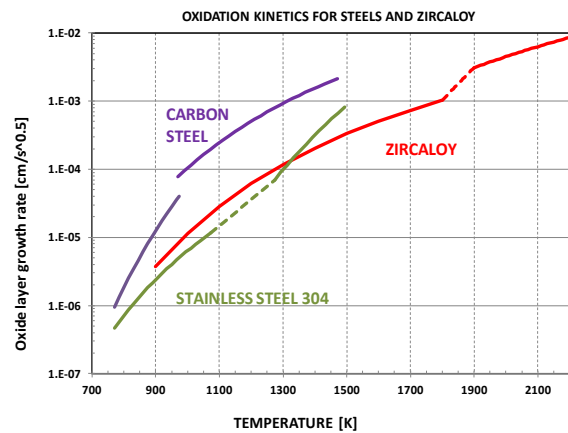
Fig.1 Oxidation Kinetics in Steam for Various Metals

Figure 1 shows the growth rate of oxide layer in Zircaloy, carbon steel and stainless steel 304 as function of the temperature, where the carbon steel represents the feeder, stainless steel 304 represents the end-fitting, Zircaloy represents the fuel sheath and pressure tube. As can be seen in this Figure, the steel oxidation by steam starts at lower temperatures, and is faster than oxidation of Zircaloy at the same temperature, and is energetic with exothermic heat of reaction of ~ 272 kJ/mole[1].

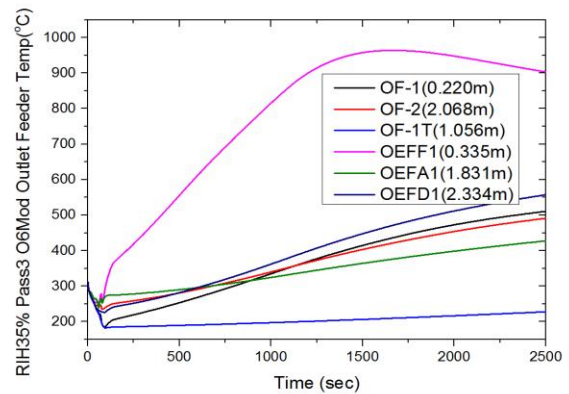
Fig.4. Outlet Feeder and End-Fitting Temperatures of O6Mod Channel at Pass 3 for RIH 35% Break LOCA with ECCS Impaired

Figures 3 to 7 show the results of the major related parameters of O6Mod, G5 and B10 channels such as the steam and D₂ Mixture temperatures at 12 axial bundle positions and the temperatures of outlet feeder and end-fittings at Pass 3 or 4 for 2500 seconds. Pass 3 and 4 represents the core pass composed of 95 fuel channels located respective upstream and downstream of the broken RIH. The predicted temperatures of the outlet feeder and end-fittings for Pass 4 are shown lower than those for Pass 3. This is because most of the pressure tube portions located at high power region of the channel center contact with the cold calandria tube due to PT ballooning early in the accident, say from 30 sec to 100 sec, and thus become cooldown. The outlet end-fitting temperature (node OEFF1) of O6Mod channel reveals that it reaches ~ 800°C at 1000 sec, 900°C at 1250 sec, which corresponds to a growth rate of stainless steel 304 oxide layer above 1.E-05cm/s^{0.5} in Fig.1. Even in the lower power channel like G5 and B10, the temperatures of end-fittings are still quite high ~ 800°C at 2500 sec. In addition, the temperatures of the other end-fittings such as node OEFA1 and OEFD1 are in the range of 400 ~ 500°C in the channels surveyed. These results reveal that the metal-water oxidation model for the steel components needs to be included in the safety analysis codes for DBA and severe accident, especially because of its safety implication to the estimation of hydrogen source term for the later containment analysis as pointed out by Song and et al. [1].
