## Influence of Plastic Deformation on the Corrosion Behavior of Alloy 690TT in Crevice Condition of a Steam Generator

\***Keywords** : steam generator, Alloy 690, plastic deformation, corrosion behavior, crevice, impurity

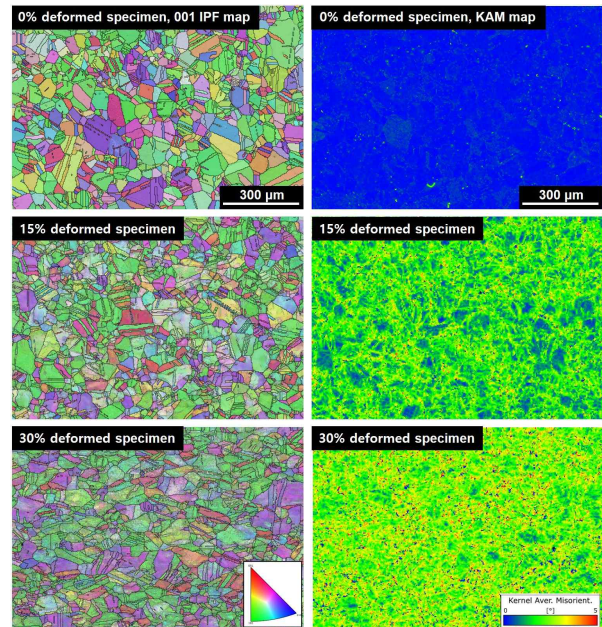
Fig. 1 shows the EBSD analysis results (001 IPF map and KAM map) of non-deformed and plastic deformed Alloy 690TT specimens. In the 001 IPF orientation map, a random orientation was observed (predominant orientation color did not appear). KAM map indicates that the crystal orientation deviation between a kernel center point and the neighboring points. As shown in Fig. 1, the misorientations of Alloy 690TT specimens do not exceed 5°. KAM map of non-deformed specimen is blue color. However, KAM map of 15% and 30% plastic deformed specimens is mixed color with blue, green, and yellow. Average KAM results of three specimens (0%, 15%, and 30% plastic deformed specimens) were 0.11, 1.73, and 2.39°, respectively. As the plastic deformation increased, the average KAM also increased because the plastic deformation increases the average direction deviation angle by inducing slip within the microstructure [6].

Fig. 1. EBSD analysis results of non-deformed and plastic deformed Alloy 690TT specimens.

(1) Plastic deformation of Alloy 690TT greatly affects the change of microstructure. As the plastic deformation of specimen increased, the average KAM increased. Average KAM results of three specimens (0%, 15%, and 30% plastic deformed specimens) were 0.11, 1.73, and 2.39 °, respectively.

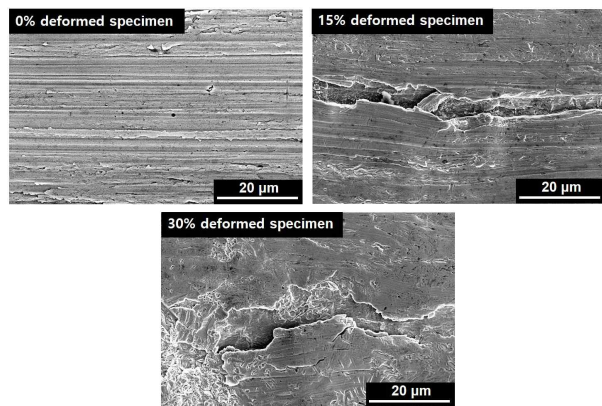
Fig. 2 shows the SEM micrographs of non-deformed and plastic deformed Alloy 690TT specimens before the corrosion test. The non-deformed specimen was generally flat and smooth. No damage or cracks were observed on the surface of non-deformed specimen. However, the some damage or micro-cracks were observed on plastic deformed specimens. As the degree of deformation of specimen increased, the number of damage and cracks increased. During the plastic deformation process, the surface of Alloy 690TT

specimen could be damaged such as strain concentration, void formation, and carbide fracture at grain boundaries [7].

In addition, the specimen surface becomes unstable due to the dislocation and slip of material atoms. We think that the damage and cracks formed on specimen surface could be affected on the corrosion behavior.

Fig. 2. SEM micrographs of surface of the specimens before the corrosion test.

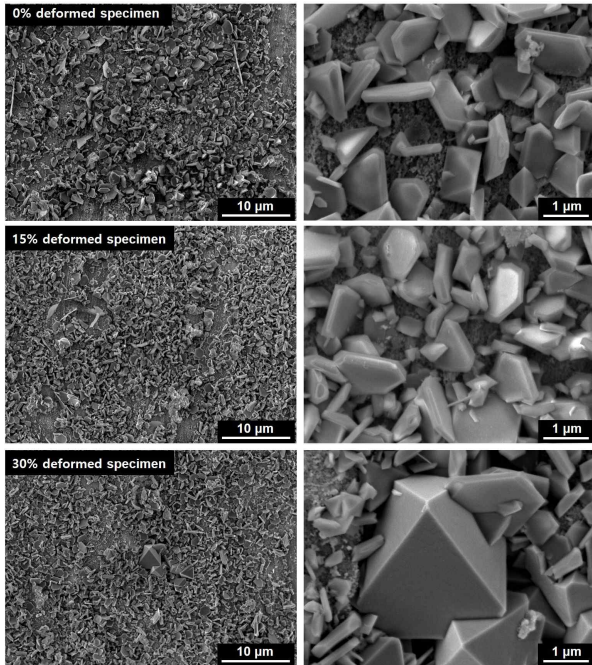
Fig. 3 shows the SEM micrographs of non-deformed and plastic deformed Alloy 690TT specimens after the corrosion test for 1000 h. The planar-like oxides and polyhedral oxides were formed on all specimens. However, the oxide particles were more densely formed on the 30% plastic deformed specimen compared to the 0% plastic deformed specimen. In particular, the large polyhedral oxide particles with the size of about 5-6  $\mu\text{m}$  were observed on 30% plastic deformed specimen.

Fig. 3. SEM micrographs of surface of the specimens after the corrosion test for 1000 h.

These results indicate that the corrosion rate of Alloy 690TT specimen increased as the deformation degree of specimen increased.

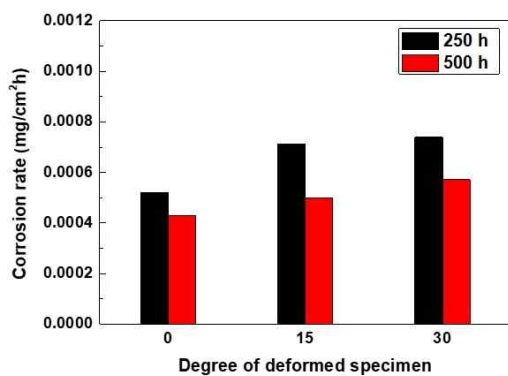
Fig. 4 shows the corrosion rate of non-deformed and plastic deformed Alloy 690TT specimens in crevice condition. Under all specimens, the corrosion rate decreased with the increasing time. In the case of 500 h, compared to non-deformed specimen, the corrosion rate of 15% and 30% plastic deformed specimens increased by about 16% and 33%, respectively. Based on the results, the plastic deformation of Alloy 690TT specimen can affect the corrosion rate.

Fig. 4. Corrosion rate of non-deformed and plastic deformed Alloy 690TT specimens in crevice condition.

(2) The corrosion rate of Alloy 690TT tube increased with increasing the degree of plastic deformation due to the formation of surface damage and cracks.
