Effect of Deformation on the Microstructure and General Corrosion Behavior of Alloy 690TT Tube in Steam Generator Crevices

***Keywords** : steam generator, Alloy 690, deformation, microstructure, corrosion, crevice

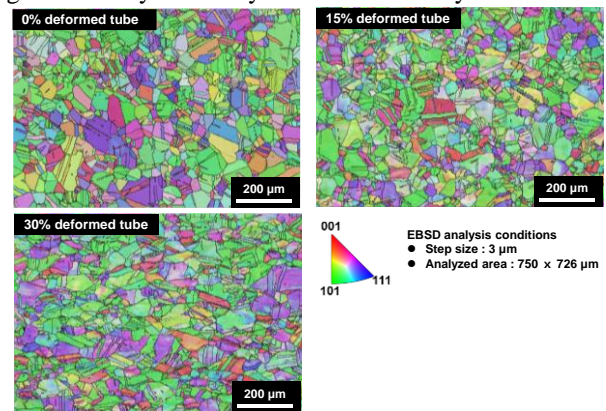
The microstructure of the specimens with different degrees of deformation was characterized by EBSD analysis. Fig. 3 shows the EBSD 001 inverse pole figure (IPF) map of non-deformed and deformed Alloy 690TT specimens. Due to plastic deformation, many grains have been deformed. As shown in Fig. 3, regardless of degree of elongation, a random orientation was observed (predominant orientation color did not appear). In addition, plastic deformation does not significantly affect the size and number of grains.

Fig. 3. EBSD IPF of the non-deformed and deformed Alloy 690TT specimens.

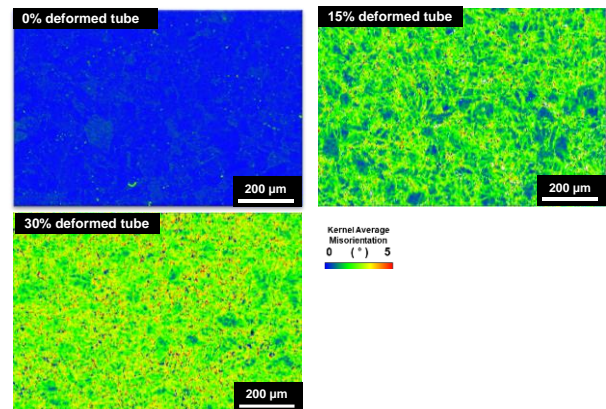
Fig. 4 shows the KAM map of Alloy 690TT specimens. KAM map indicates that the crystal orientation deviation between a kernel center point and the neighboring points. As shown in Fig. 4, the

misorientations of all specimens do not exceed 5°. In the case of non-deformed specimen, KAM map shows blue color. However, KAM map of 15% and 30% deformed specimens has the mixed color with blue, green, yellow, and red. As the elongation of specimen increased, most of them were yellow and red. Average KAM results of three specimens (0%, 15%, and 30% deformed specimens) were 0.11, 1.73, and 2.39°, respectively. As the plastic deformation increased, the average KAM increased because the plastic deformation increases the average direction deviation angle by inducing slip within the microstructure [6].

Fig. 4. KAM maps of the non-deformed and deformed Alloy 690TT specimens.

Using the KAM results, burgers vector, and step size, geometric dislocation density could be calculated. As a results, as the elongation of specimen increased, the geometrically necessary dislocation density increased.
