# Functional Qualification of Active Valve used in Ki-Jang Research Reactor

Hyunwoo Lee\*, Dayong Kim, InGuk Kim, Kyungwoo Seo  
Korea Atomic Energy Research Institute, 111, Daedeok-daero, Yuseong-gu, Daejeon  
\*Corresponding author: LHW@kaeri.re.kr

**\*Keywords : Functional Qualification, Active Valve, Ki-Jang Research Reactor, KEPIC MFC, ASME QME-1**

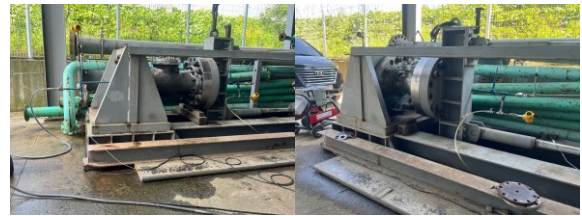
of the test valve assembly before actual testing and establishes baseline values to assess potential performance degradation - primarily increased valve seat leakage - during subsequent tests. The pre-test inspection included a visual examination of the test valve assembly and calibration of test equipment. The primary seat leakage was measured for at least 5 minutes, with an allowable leakage rate of 0.6 in<sup>3</sup>/hr per nominal pipe size (NPS) of the valve.

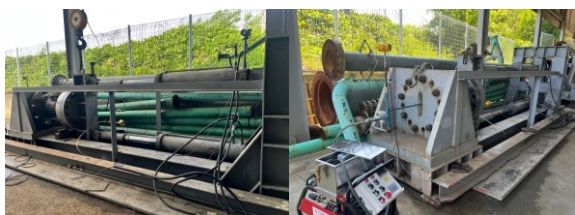
The piping reaction end-load test was performed per MFC 4470.2. The objective of this test was to verify that the test valve assembly operates normally while subjected to all required piping end loads in addition to normal loads. The valve inlet side was fixed to a support, while the outlet side was attached to a movable fixture. Opposing forces were applied to the top and bottom of the valve to generate the test moment required by the technical standard. This state was maintained for 5 minutes, after which the test moment was reduced to 2/3, and the primary seat leakage was measured for 5 minutes.

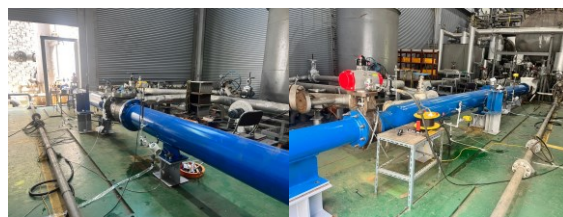
This test was conducted in accordance with MFC 4490.2. It evaluates the valve's operational performance under backflow conditions and the tendency of the disc to deform due to differential pressure upon closure. The test also confirms that the valve disc remains in a fully open position during normal operation. The test valve was installed in reverse between a water storage tank and a quick-opening valve. After ensuring that the valve disc was held open, the quick-opening valve at the end of the test loop was opened, creating an instantaneous backflow condition.

If the test was conducted at the highest required closing velocity, a single test was sufficient. Otherwise, three tests were required at different closing velocities.

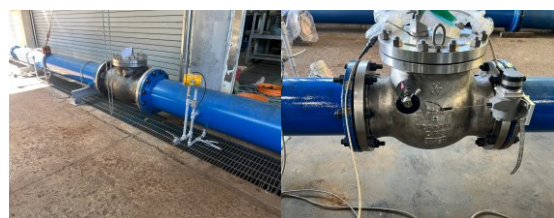
This test was conducted per MFC 4491.2 to determine the velocity and mass flow rate when the valve reaches a fully open and stable position. To protect the valve from turbulence, a straight pipe section of 10D was installed upstream. The flow rate was gradually increased, and once the valve disc reached its fully open position, velocity, density, and pressure were measured. This test was repeated three times to obtain stable data.

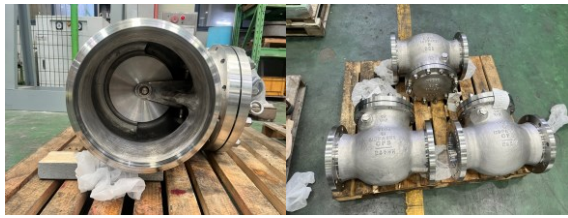
Upon completion of all tests, a final seat leakage test was conducted, following the same procedure as the pre-test and intermediate inspections. The test valve assembly was then completely disassembled and thoroughly inspected for visible wear or damage, with all observations recorded.
