## On the Wrong Use of Sodium Hydroxide as a Chemical Impurity Concentrated in Nuclear Steam Generator Crevices

Do Haeng Hur<sup>a\*</sup>, Geun-Dong Song<sup>b</sup>, Jeoh Han<sup>a</sup>, Soon-Hyeok Jeon<sup>a</sup>

<sup>a</sup> Nuclear Materials Research Division, Korea Atomic Energy Research Institute, Daejeon 34057 <sup>b</sup> Nuclear Materials Research Group, FNC Technology Co., Ltd., Yongin 17084 <sup>\*</sup>Corresponding author: dhhur@kaeri.re.kr

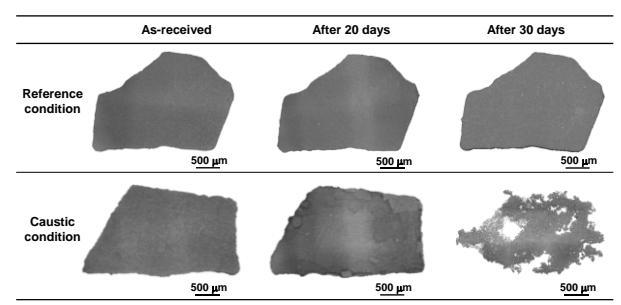
Fig. 1 shows the optical images of the SG deposit flake samples exposed to the two different water chemistry conditions at 300 °C. In the reference solution, there was no change in the surface morphology of the sample up to 30 days. However, the sample immersed in the caustic solution was rapidly dissolved and only a certain amount of the flake was left after the 30-day immersion.

Fig. 1. Optical images of the SG deposit flake samples exposed to the two different water chemistry conditions.

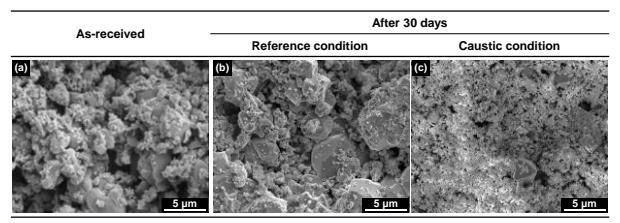
The surface morphologies of the samples exposed to the solutions were further examined using SEM. As shown in Figs. 2a and 2b, the size and shape of the particles of the deposit flakes did not change after exposure in the reference solution for 30 days. However, comparing Fig. 2c with 2a, the size of the particles was significantly decreased, and the shape tended to have more rounded edges, indicating that the deposit particles were dissolved in the caustic solution.

Fig. 2. SEM micrographs showing the surface morphology of the SG deposit samples exposed to the two different water chemistry conditions at 300 °C for 30 days.

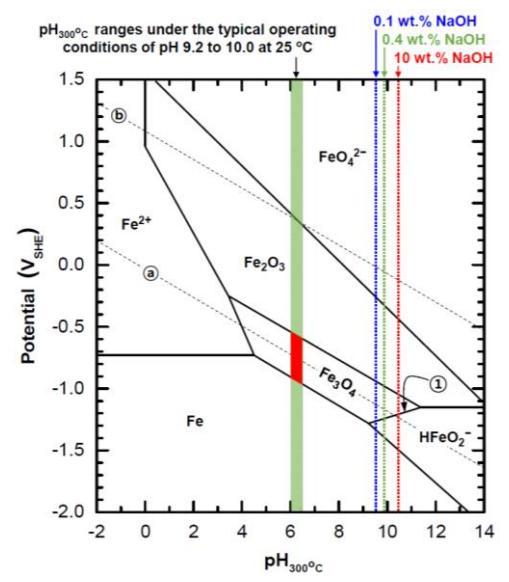
The SG deposits used in this study can be assumed to be magnetite because they are mostly composed of magnetite [6]. Therefore, the stability of the magnetite deposits can be inferred using a potential-pH diagram. Fig. 3 shows the potential-pH equilibrium diagram for an iron-water system at 300 °C [7]. pH values at 300 °C in various environments were calculated using the MULTEQ code and presented in the diagram.

It can be deduced that the SG magnetite deposits were formed within the stable domain of magnetite, which is shown in the red box. Similarly, the lack of dissolution of the deposit flakes immersed in the reference solution indicates that the deposits are still located in the stable area of magnetite during the immersion tests.

Fig. 3. Potential-pH diagram for the iron-water system at  $300 \text{ }^{\circ}\text{C}$  [7]. pH values at  $300 \text{ }^{\circ}\text{C}$  in various environments were calculated using the MULTEQ code and superimposed in the diagram.

The equilibrium of this reaction is expressed by line  $\mathbb{O}$  in Fig. 3. The equilibrium potential (*E*) of reaction (1) at 300 °C can be calculated using the following Nernst equation (2):

For 0.4 wt.% NaOH solution, since magnetite is dissolved, the potentials at which the HFeO<sub>2</sub><sup>-</sup> species (dihypoferrite ion) is stable are in the range of -1.239 to -1.395 V<sub>SHE</sub> shown in Fig. 3. From Eq. (2), these values correspond to an  $a_{HFeO_2^-}$  of 0.73 to 6.0. Consequently, these calculations provide evidence that magnetite is thermodynamically unstable in 0.4 wt.% NaOH solution, leading to a dissolution to HFeO<sub>2</sub><sup>-</sup> ions. In a similar manner, we can predict that magnetite is no more stable in a caustic solution containing NaOH over 0.1 wt.% under the reducing environments of SGs.
