An Overview of Hydrogen Degradation of Structural Materials in Nuclear Energy System

Jun Yeong Jo^a, Hwasung Yeom^{a*}

^aDivision of Advanced Nuclear Engineering, Pohang University of Science and Technology (POSTECH), Pohang, 37673, Republic of Korea *Corresponding author: hyeom@postech.ac.kr

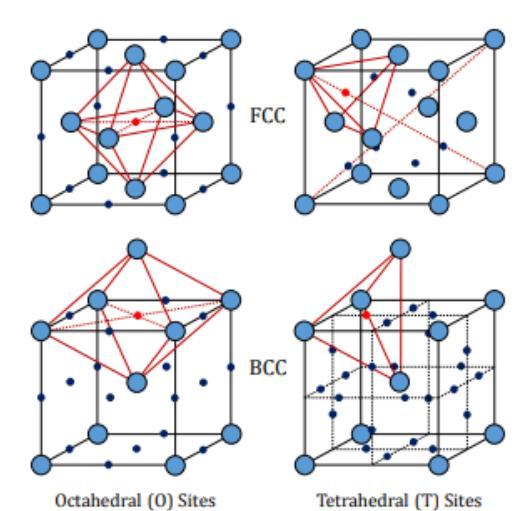
Fig. 1 Octahedral (O) and Tetrahedral (T) sites in FCC lattice and BCC lattice [3]

As shown in Figure 1 and Table 1, octahedral site and tetrahedral site may exist in FCC and BCC, which are representative iron crystal structures, respectively, and in FCC structure such as austenite, the radius of octahedral site with a larger interstitial site space is 0.52 Å, which is larger than the radius of the hydrogen atom, so a large amount of hydrogen atoms can be dissolved in to the material as solute. On the other hand, in BCC such as ferrite, the larger interstitial sites are tetrahedral site and the size of the tetrahedral site is 0.35 Å, which could be quite low in hydrogen solute compared to the radius of the hydrogen in FCC steels is generally larger than that of BCC steels.
