# Comparative Study of Corrosion Products Formed in Feedwater Heaters of Pressurized Water Reactor

\*Keywords : Pressurized water reactor, Feedwater heater, Corrosion product, Atmospheric corrosion, Lay-up

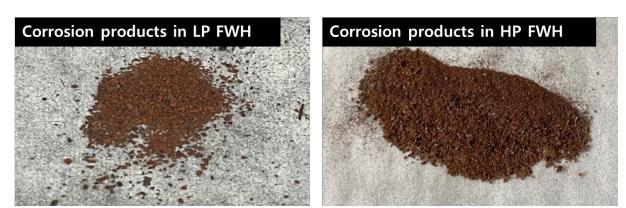
Fig. 1 shows the OM images of corrosion products collected from the LP FWH and HP FWH. The samples from the LP FWH were generally red, while those from the HP FWH were dark-red. These color differences suggest the presence of different iron oxides and oxyhydroxides.

Fig. 1. OM images of the samples collected from LP FWH and HP FWH.

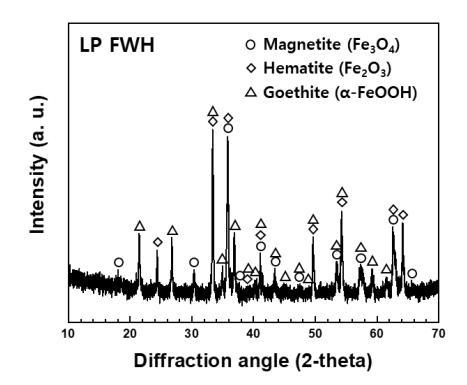
Figs. 2 and 3 show the XRD results of the samples from LP FWH and HP FWH, revealing distinct differences between them. The LP FWH sample identified peaks for hematite, goethite, and magnetite. The HP FWH sample identified peaks for goethite, lepidocrocite, and magnetite, but no peaks for hematite. These results indicate that there is a difference in the crystal structure of the corrosion products depending on the operational conditions at the two positions.

Fig. 2. XRD result of the corrosion product collected from LP FWH.

Corrosion products collected from LP and HP FWHs were characterized using OM, ICP-MS, XRD, and SEM. The results revealed that hematite is the dominant corrosion product in LP FWH, while magnetite was predominantly formed in the HP FWH. However, SEM results indicated that the characteristic polyhedral morphology of magnetite was not observed, and only the distinct morphology of iron oxyhydroxides was present. These results deviated from the expected corrosion behavior in the HP FWH and were considered to be influenced by exposure to the atmosphere after shutdown.

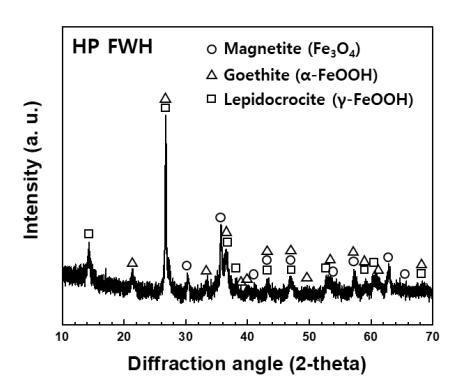
Fig. 3. XRD result of the corrosion product collected from HP FWH.

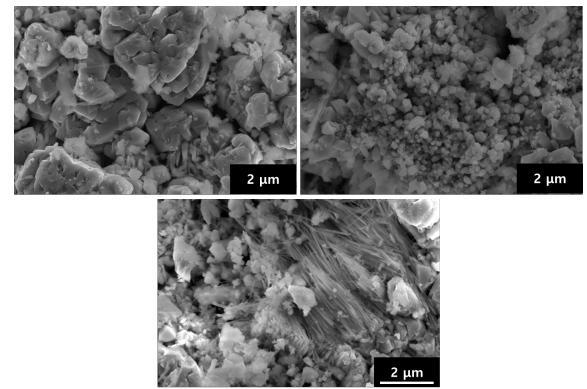
Fig. 4 shows the SEM images of the LP FWH sample with various particle morphologies including polyhedral, spherical, and rod-like forms. The chemical composition of the polyhedral forms consists of approximately 54.3 at.% and 45.7 at.% Fe, the spherical forms consist of approximately 60.8 at.% O and 39.8 at.% Fe, and the rod-like forms consist of approximately 59.0 at.% O and 41.0 at.% Fe.

Fig. 4. SEM images of the corrosion products collected from LP FWH.

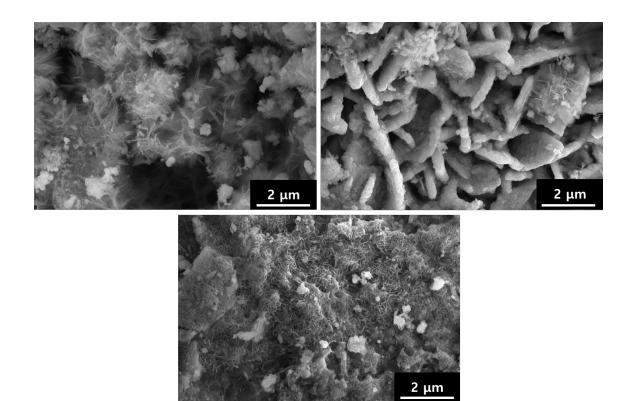
Fig. 5 shows the SEM images of the HP FWH samples with different particle morphologies such as thin and flat sheet, bar, and thorny forms. The chemical composition of the thin and flat sheet forms consists of approximately 69.9 at.% O and 30.1 at.% Fe, the bar forms consist of approximately 60.9 at.% O and 39.1 at.% Fe, and the thorny forms consist of approximately 69.4 at.% O and 30.6 at.% Fe. Notably, the polyhedral morphology that is characteristic of magnetite was not observed. As magnetite was detected by the XRD analysis, it is suggested that magnetite may be present inside the sample.

Fig. 5. SEM images of the corrosion products collected from HP FWH.
