Effects of steam and chemical spray solution on degradation of non-metallic materials

*Keywords : Design Basis Event, Chemical Spray, Material Degradation, Hydrolysis, Thermal aging

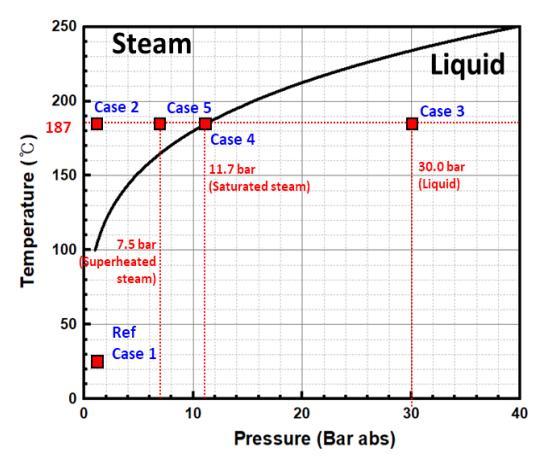
Fig. 1. Saturation vapor pressure curve and test conditions

In the degradation test, 28% acrylonitrile NBR was used, and specimens were designed in accordance with the ISO-37 type 2 standard for tensile testing. A total of 15 specimens were tested for each test case. To simulate the degradation under various condition of post DEC environment for 24 hours, degradation tests were conducted for a total of 5 test conditions, as shown in Fig. 1. Based on previous studies, at the post DEC temperature of 187°C, case 2 was tested in an atmospheric environment without steam, while case 3 was tested in an immersed condition with 30.0 bar abs. Case 4 and 5 were tested in steam environment at 11.7 and 7.5 bar abs, respectively. For immersion and steam test, a solution with a boron concentration 4400 ppm was used to simulate a chemical spray solution. As shown in Fig. 2, a testing loop was designed for the test case 3~5, and the specimens were placed in the autoclave test section.

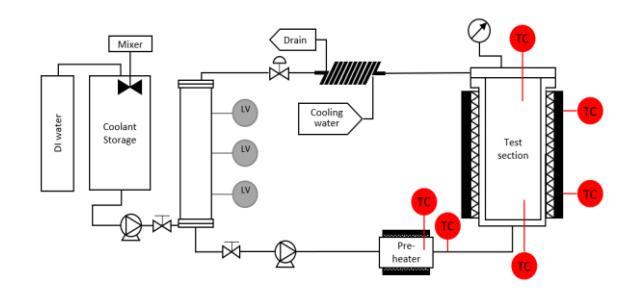
Fig. 2. Schematic diagram of testing loop for the degradation tests

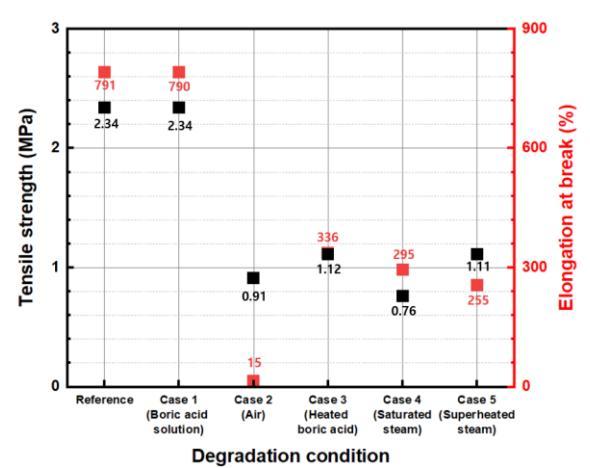
As shown in Fig. 3 and 4, there was no significant change of tensile properties between the reference (nondegraded condition) and case 1, where the specimens were immersed in a chemical spray solution at room temperature and atmospheric pressure. Similarly, shore A hardness did not significantly change between the reference and case 1. These results indicate that, under room temperature conditions, a 24 hours exposure to the chemical spray solution does not significantly contribute to the degradation of NBR. In case 2, the most significant degradation trend was observed. The EAB decreased from 791 to 15%, while the shore A hardness increased from 64.83 to 89.75, indicating severe hardening. This hardening phenomenon intensified in the order of case 3, case 4, and case 5. These results demonstrate that at 187°C, degradation in a steam environment is more severe than in an immersion condition with boric acid solution. Furthermore, the hardening effect was measured to be higher in the order of case 3, 4, and 5. Since case 4 contained a larger volume of steam in the test section compared to case 5, the formation of a moisture film on the specimen surface and the lower oxygen fraction in the atmosphere contributed to a slower acceleration of the autooxidation mechanism in case 4 than in case 5.

Fig. 3. Elongation at break (EAB) and tensile strength of degraded NBR

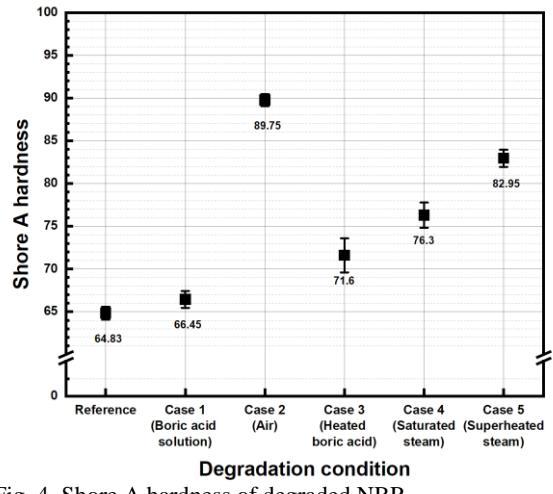
Fig. 4. Shore A hardness of degraded NBR

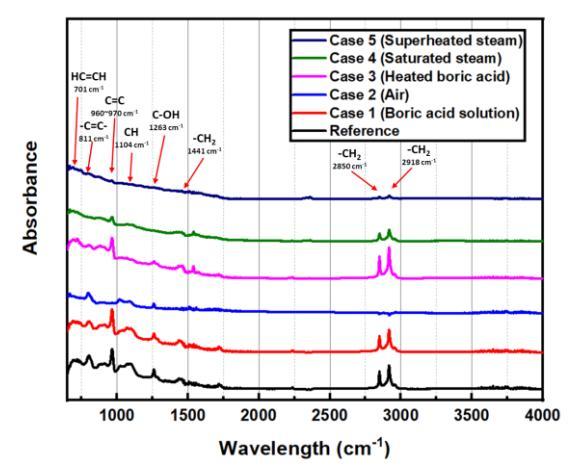
In Fig. 5, the FT-IR spectra after the degradation test were analyzed. The absorbance intensity of the CH bond (1104 cm⁻¹) and CH₂ bond (1441 cm⁻¹) decreased after the degradation test. It is considered that the thermal energy applied during the degradation test caused the cleavage of CH bonds, resulting in a decrease in absorbance intensity in the FT-IR spectrum. In case 4 and 5, where the tests were conducted in a steam environment, the absorbance intensity of the C=C bond 701, 811, and 960-970 cm⁻¹) decreased. This degradation behavior was similar to the behavior observed in mechanical properties and the hardening behavior, which can be attributed to molecular structural changes caused by the auto-oxidation mechanism. The degradation initiation site of NBR is known to be the C=C bond in the butadiene group. During the test, the thermal energy applied to the specimen cleaved the C=C bond, accelerating the degradation process. Therefore, the extent of degradation can be assessed based on the degradation intensity of the C=C bond. [4].

Fig. 5. FT-IR spectra of degraded NBR

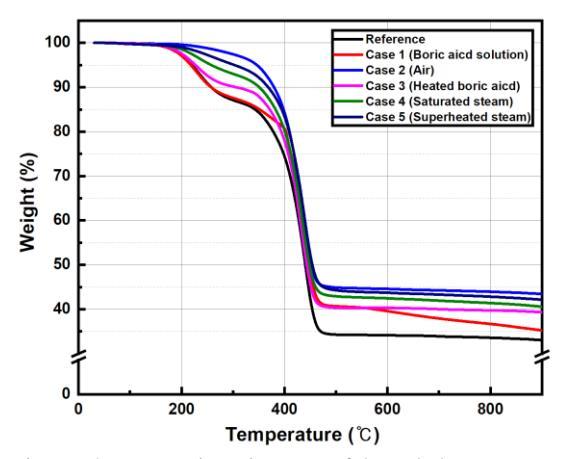
As shown in Fig. 6, the thermogravimetric curve was observed to behave differently depending on the test case. In particular, thermal degradation around 320°C shows a clear distinction between the cases. While the reference case and case 1 showed no significant difference, case 2, which was tested in atmospheric air at 187°C, exhibited a notable difference compared to the reference case. Furthermore, the discrepancy from the reference case was greater in case 3, 4, and 5, in that order. This trend is consistent with the hardening behavior observed in mechanical properties

Fig. 6. Thermogravimetric curve of degraded NBR

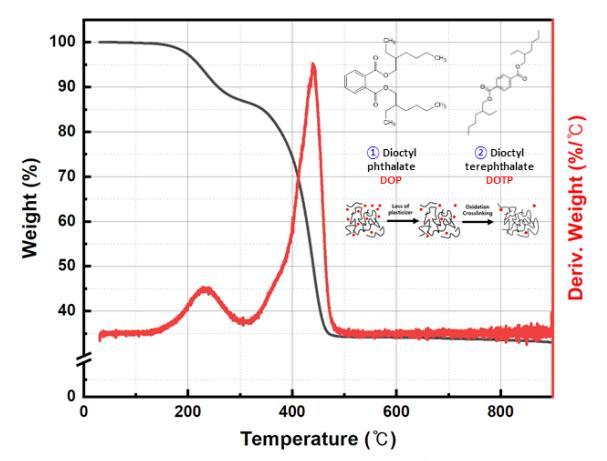
The weight loss around 320°C during thermal degradation was analyzed to result from the volatilization of plasticizers such as dioctyl phthalate (DOP) and dioctyl terephthalate (DOTP), as shown in Fig. 7. Plasticizers, which have a polar portion, are added to decrease intermolecular forces and improve processability. However, as the plasticizers volatilize, the intermolecular forces increase, bringing molecules

into closer proximity. This accelerates crosslinking, as structures containing free radicals generated from the cleavage of chemical bonds due to thermal energy can form additional crosslinked structures. Consequently, these structural changes affect the bulk mechanical properties, ultimately leading to hardening. [5].

Fig. 7. thermogravimetric curve and 1st derivative weight curve of degraded NBR

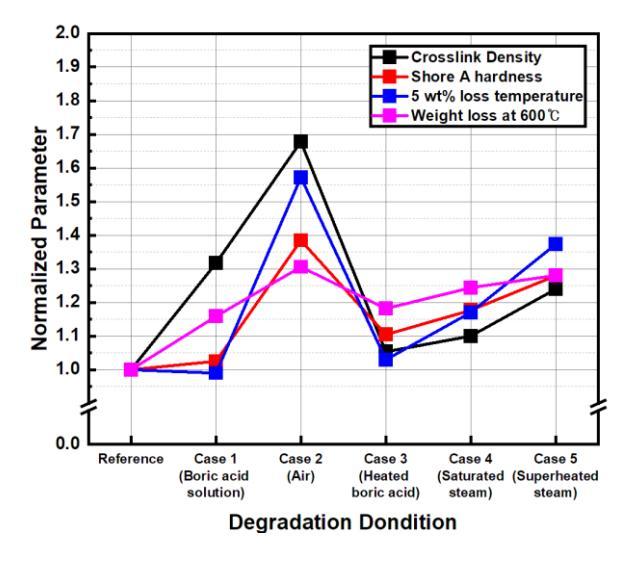
As a result, the degradation trend shown in Fig. 8. was observed, and the hardening effect, represented by the increase in shore A hardness, was affected by the previously mentioned degradation factors.

Fig. 8. Normalized material properties of degraded NBR
