《Technical Note》

## **Evaluation of Nuclear Plant Cable Aging Through Condition Monitoring**

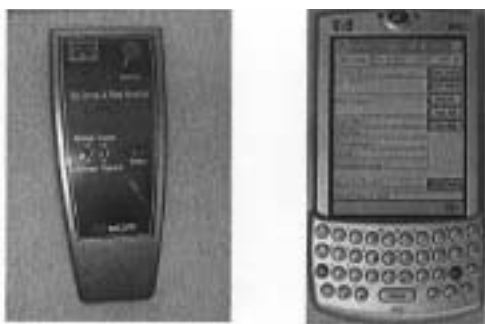
**Fig. 4.5. Electronic Temperature Recorder**

A special electronic thermometer was invented for temperature monitoring in NPPs [8]. This device was designed to measure the plant environment temperature during a single outage period (12-

18months). In addition, a semiconductor sensor is equipped to detect low battery consumption. Measured data can be transferred to a PC by infrared transmission. Compression methodology, which is a way to record any new data that is different from a previous data, can reduce the IC memory requirement by 1/100. Fig. 4.5 shows pictures of the electronic temperature recorder and a PDA for remote control record setting. Fig. 4.6 shows the result of temperature monitoring conducted for 395 days on the surface of pressurizer (PZR) power cable in Kori-1. From the

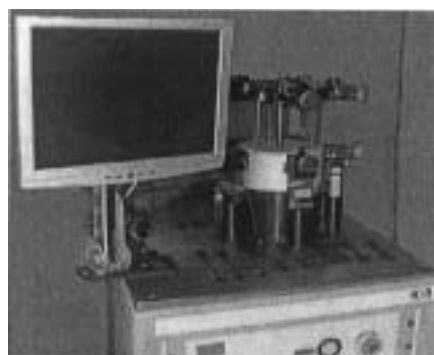
**Fig. 4.7. Break-Elongation Test Machine**

An elongation test is was performed in accordance with the ASTM D412 (Rubber properties in tension) [9]. Fig. 4.7 shows the break-elongation test machine and Fig. 4.8 shows a wedge type manual grip of the break-elongation tester. After 5 break-elongation tests, 3 medium value data were selected to evaluate the cable life.

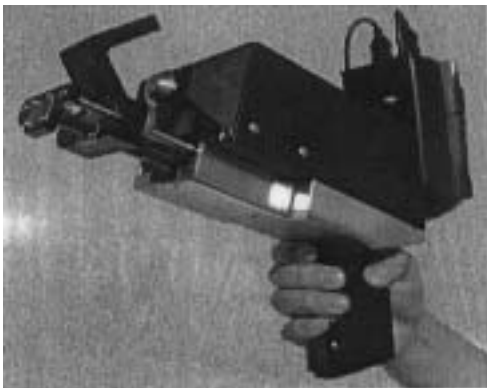
**Fig.4.9. Portable Cable Indenter at KEPRI**

tend to show signs of aging degradation. One of these symptoms is the hardening of the cable material. An indenter was designed to measure the hardness of the cable jacket. It is a very convenient tool for condition monitoring of nuclear cables since it uses a non-destructive method for diagnosing the extent of cable aging. This tool uses the modulus value, which is calculated by dividing the force by the moving distance of the anvil, to detect aging degradation of the cable. Fig. 4.9 shows a picture of a portable cable indenter used at KEPRI [10]. Fig. 4.10 shows the “Force-distance”curve of the
